County Safety Projects – Closer Look

Case Study: Broadmoor Safe Routes to School Pedestrian Improvements

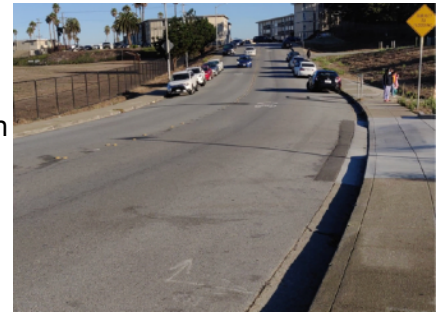
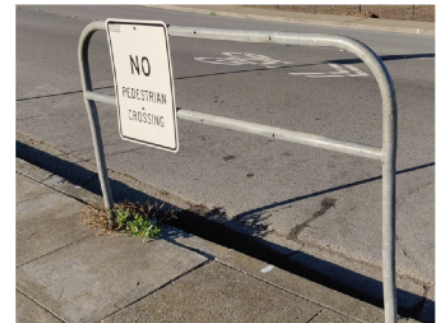
Before Photos

Before and after photos help to see why a mid-block crosswalk was needed and an improvement; however, on closer examination several dangers have been created and needed improvements not implemented.

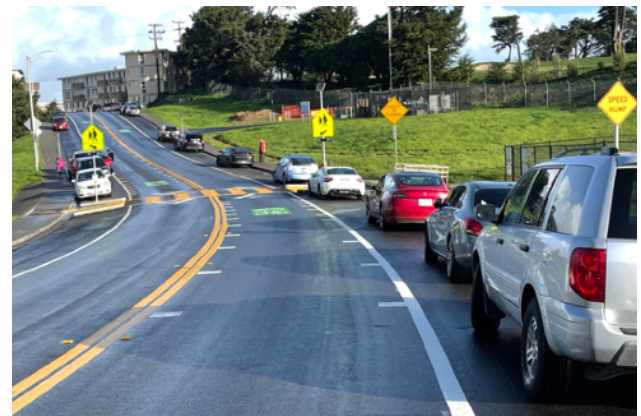
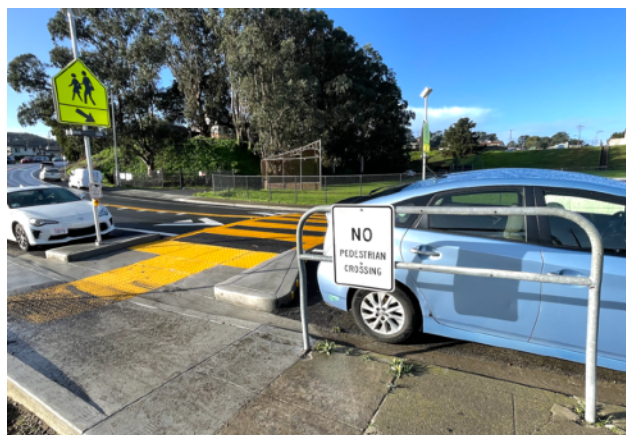
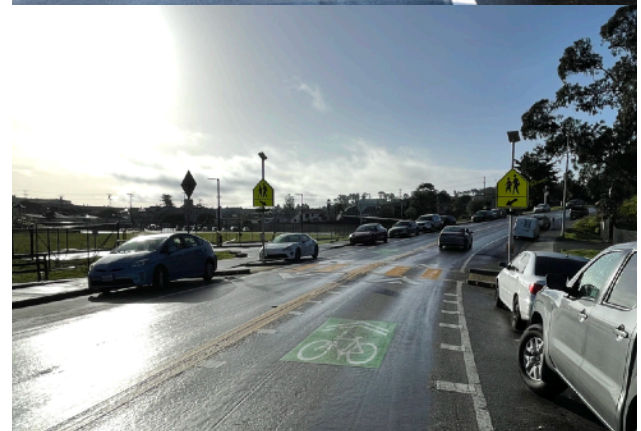
After Photos

The deceleration marks, a new approach for County, seem to work well for motorists not familiar with this road; however, it seems that a large percentage of motorists are not slowing down - probably because the raised crosswalk is barely felt by the motorists. Virtually no sensation of a hump and no tactile reason to slow down. So the bottom line, crosswalk was raised to calm traffic and slow vehicles, but it is not meeting that important goal.

A street lighted crosswalk would have been a major safety improvement. Correcting county's many dark non-lighted crosswalk should be a priority and be considered for every improvement project. In this case, where a new crosswalk is installed, it seems a street lighted crosswalk should have been required. The existing street lights are too far away to properly light the crosswalk.

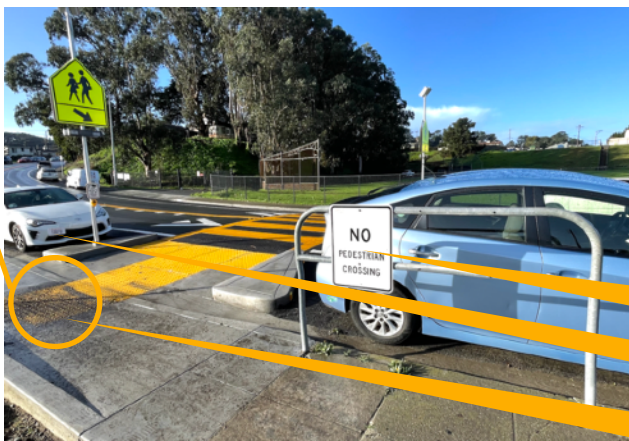
- This No Crossing sign is inches from crosswalk? If a sign is needed, shouldn't it be a different sign? Confusing.
- Parked cars block visibility
- Possible ponding-debris issue

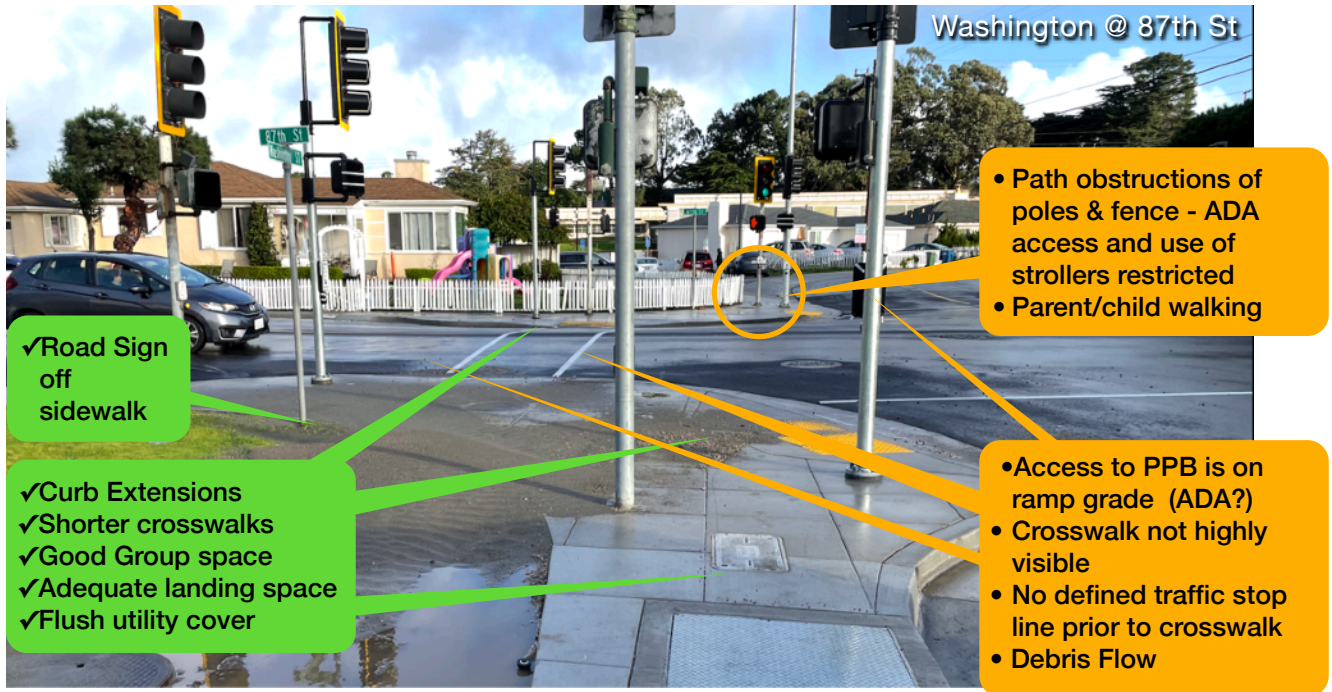
2. Intersection — Washington & 87th

Four corners of this intersection had partial or full curb extensions resulting in shorter crosswalks, larger area for students to queue, landing areas from curb ramps (most), and utility covers were flush with sidewalk making it more comfortable for people with disabilities. See illustrations below for summary of both pro and con aspects of the improvements.

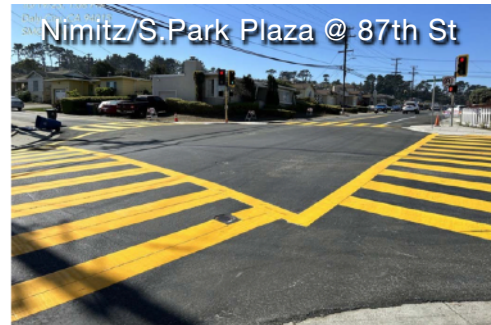
This intersection only added curb extensions on some corners and not the others. The high visibility crosswalk was retained. New traffic / lighting box appears to be in the process of being installed.

More care is needed in the construction process to accommodate pedestrian and ADA safety. Large and deep leg twisting hazards in sidewalk are dangerous for all. Extremely poor and uneven patches in sidewalk and obstacles in sidewalk make it difficult for people with disabilities. These dangerous conditions should not be permitted without a temporary alternative route being constructed, as is recommended by FHWA.

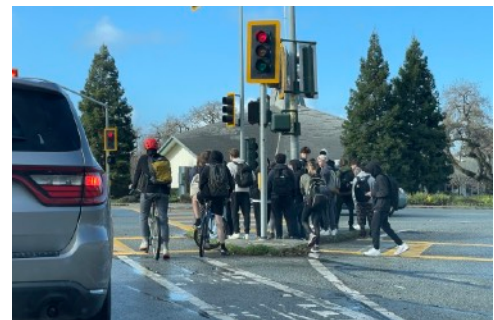
Questions arise as to why the other corners of the intersection were not improved with curb extensions. Curb extensions not only provide shorter crosswalks, but they also provide a larger queuing area for groups of pedestrians - common with schools. The current sidewalks at the corners don't provide the capacity to have student groups, bikes, strollers, and guardians holding hands with kids. People with disabilities will find these corners problematic - not ADA friendly.

School areas have groups of kids crossing, some with bikes and other modes. Wheelchairs and crutches require even more room.

Why in this project are the traffic/light control boxes right next to the narrow sidewalks, restricting sidewalks to a minimum width? This is a common problem throughout county. If traffic control boxes are installed away from the sidewalk, users have more room,

the sidewalk could even be widened rather than permanently set at a minimum or less than minimum width.

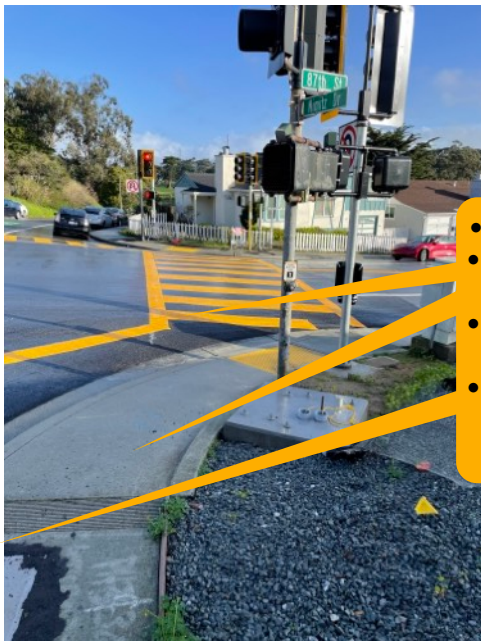
- No Curb extensions
- Unacceptable construction area - dangerous sidewalk
- New Traffic/light control box too close to sidewalk
- No Curb ramp - people with disabilities must use street to access ramp

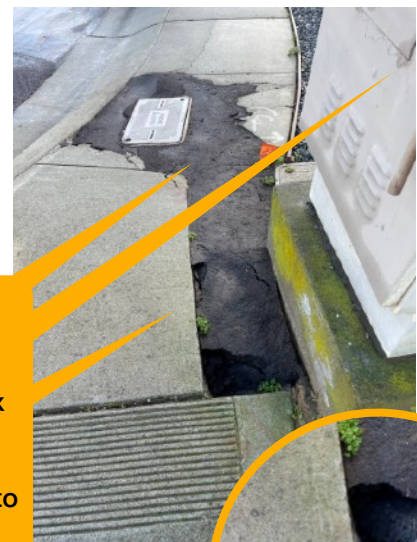
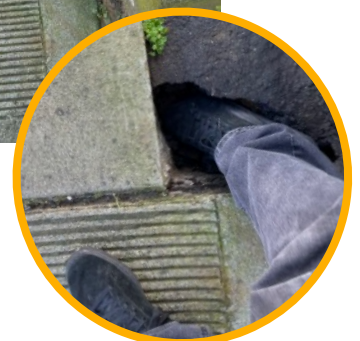
- No curb extension
- Dangerous construction leaves all at high risk
- Control boxes too close to sidewalk
- No curb ramp - must use street to access ramp
- use of strollers restricted
- Parent/child walking

- ✓Curb Extensions
- ✓Shorter crosswalks
- ✓High visibility crosswalk
- ✓Good Group space
- ✓Adequate landing space
- ✓Flush utility covers
- ✓New poles out of sidewalk path

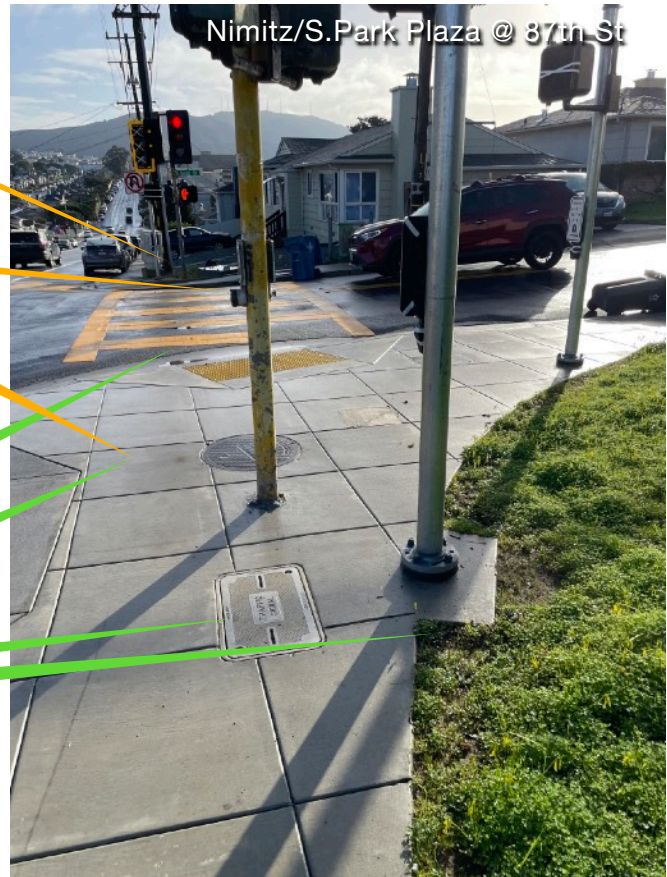
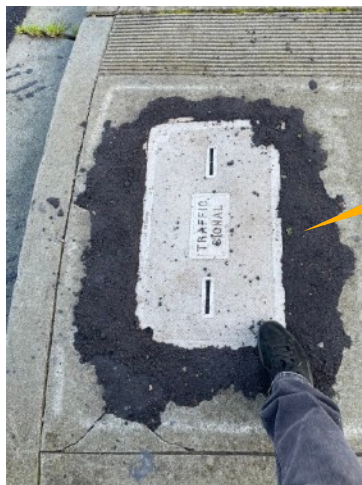
- These covers and their surrounding patches are extremely rough and lumpy - a challenge for people using wheel chairs, strollers
