**Figure 2**  
**Study Area 1: Benjamin Franklin & Garden Village Schools**  
Broadmoor, CA

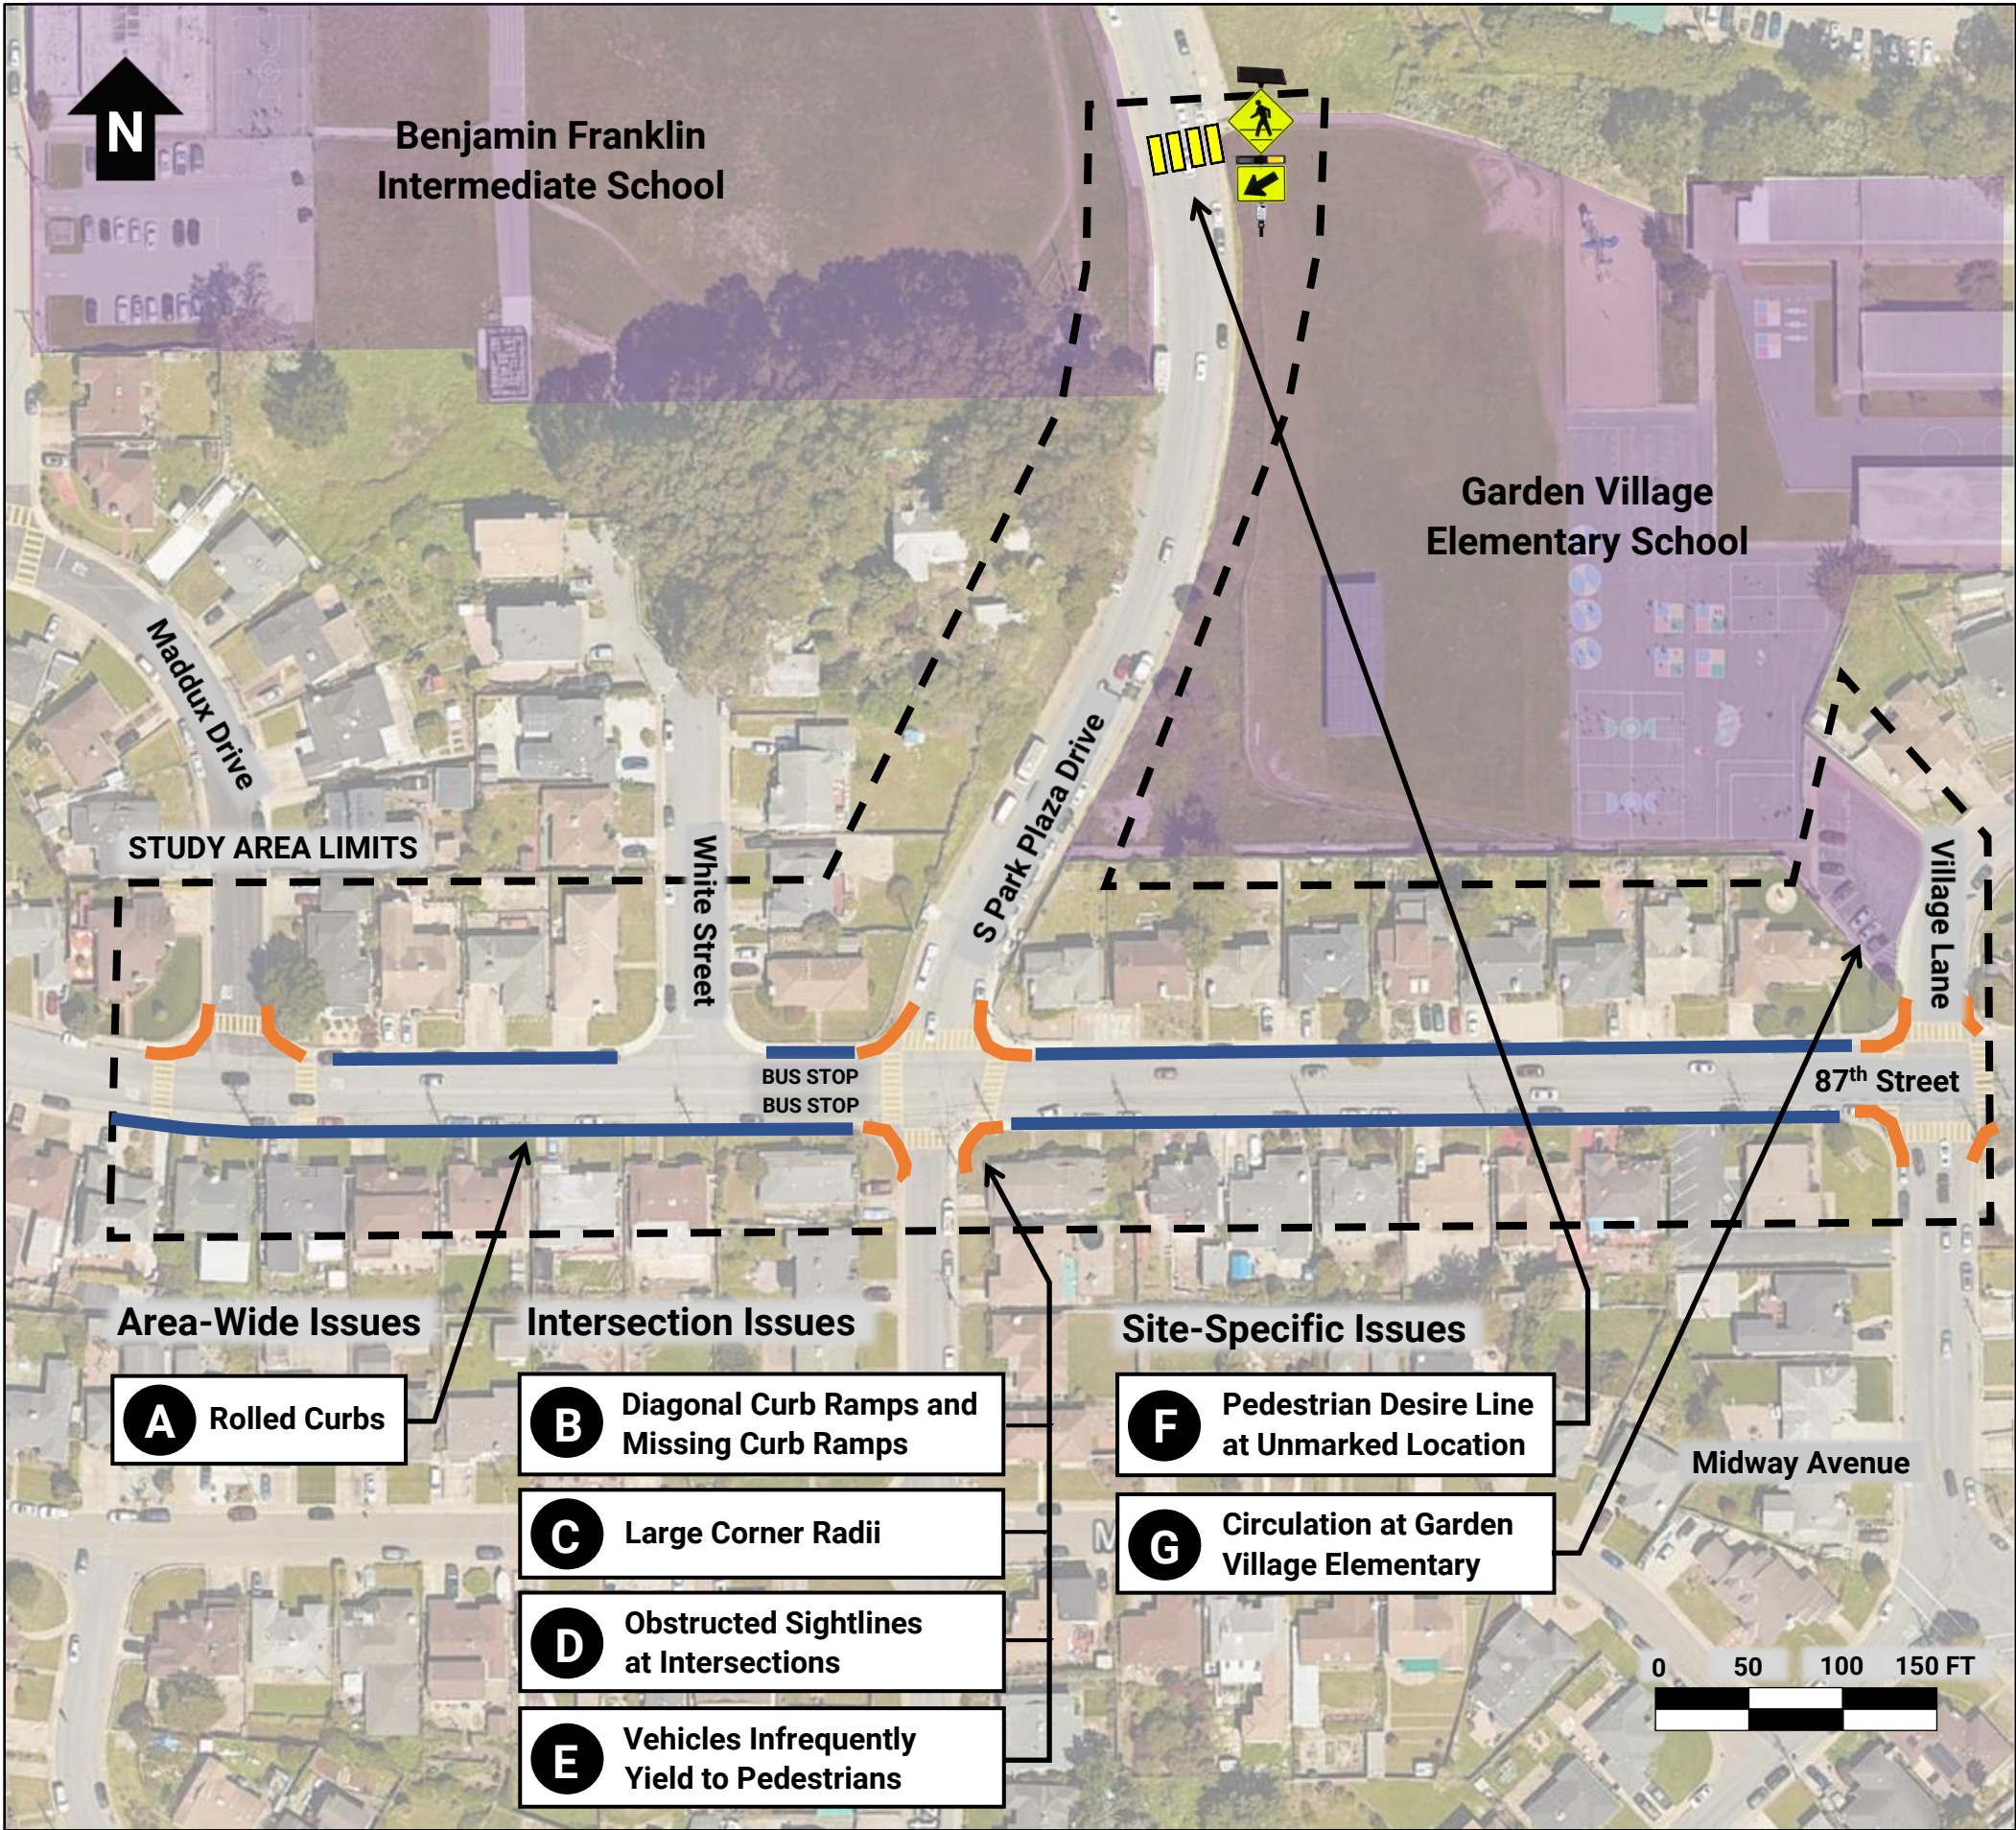
| | Issue | Recommendation |
|---|---|---|
| <b>A</b> | <b>Rolled curbs</b> encourage drivers to park partially on the sidewalk, resulting in pedestrian safety and access issues. | <b>Short-Term</b> <ul style="list-style-type: none"><li>Stripe edge lines in roadway to delineate parking lanes from travel lanes or install rubber wheel stops flush with rolled curb to prevent sidewalk parking</li><li>Conduct neighborhood educational campaign (e.g., windshield flyers) on good parking habits</li></ul> <b>Long-Term</b> <ul style="list-style-type: none"><li>Retrofit rolled curbs to vertical curbs</li></ul> |
| <b>B</b> | <b>Diagonal curb ramps and missing curb ramps</b> are a safety and ADA access issue for pedestrians. | <b>Long-Term</b> <ul style="list-style-type: none"><li>Install ADA-compliant bi-directional curb ramps that align with crosswalks at intersections on 87<sup>th</sup> Street with marked crossings</li></ul> |
| <b>C</b> | <b>Large corner radii</b> at intersections enable drivers to make high-speed right turns, which decreases the likelihood that they will yield to crossing pedestrians and increases the severity of collisions with pedestrians, should they occur. | <b>Short-Term</b> <ul style="list-style-type: none"><li>Install quick-build curb extensions with smaller radii constructed from temporary materials like paint and flexible delineators</li></ul> <b>Long-Term</b> <ul style="list-style-type: none"><li>Install concrete curb extensions with smaller radii (must account for existing drainage infrastructure)</li></ul> |
| <b>D</b> | <b>Obstructed sightlines at intersections</b> reduce the visibility of pedestrians and other vehicles to drivers. | <b>Short-Term</b> <ul style="list-style-type: none"><li>Establish “no parking” zones within 20 feet of intersections</li></ul> <b>Long-Term</b> <ul style="list-style-type: none"><li>Install concrete curb extensions</li></ul> |
| <b>E</b> | <b>Turning vehicles infrequently yield to pedestrians</b> , necessitating the use of crossing guards during school hours. | <b>Short-Term</b> <ul style="list-style-type: none"><li>Install Leading Pedestrian Intervals (LPIs) at signalized intersections, which provide pedestrians with a walk signal 3 to 7 seconds before vehicles traveling in the same direction receive a green indication, so pedestrians establish the right-of-way in the crosswalk</li></ul> |
| <b>F</b> | <b>Pedestrian desire line at unmarked location</b> results in unsafe midblock jaywalking. | <b>Long-Term</b> <ul style="list-style-type: none"><li>Install marked crossing, RRFBs, curb extensions, and curb ramps</li></ul> |
| <b>G</b> | <b>Circulation at Garden Village Elementary</b> is inefficient and results in a narrow pedestrian entrance to the school. | <b>Short-Term</b> <ul style="list-style-type: none"><li>Use temporary materials like cones to reconfigure the drop-off zone on Village Lane into a semi-circular circulation loop without parking spaces and a smaller footprint</li></ul> <b>Long-Term</b> <ul style="list-style-type: none"><li>Use permanent installations like curbing and landscaping to reconfigure the drop-off zone into a circulation loop and widen the sidewalk to the school campus</li></ul> |

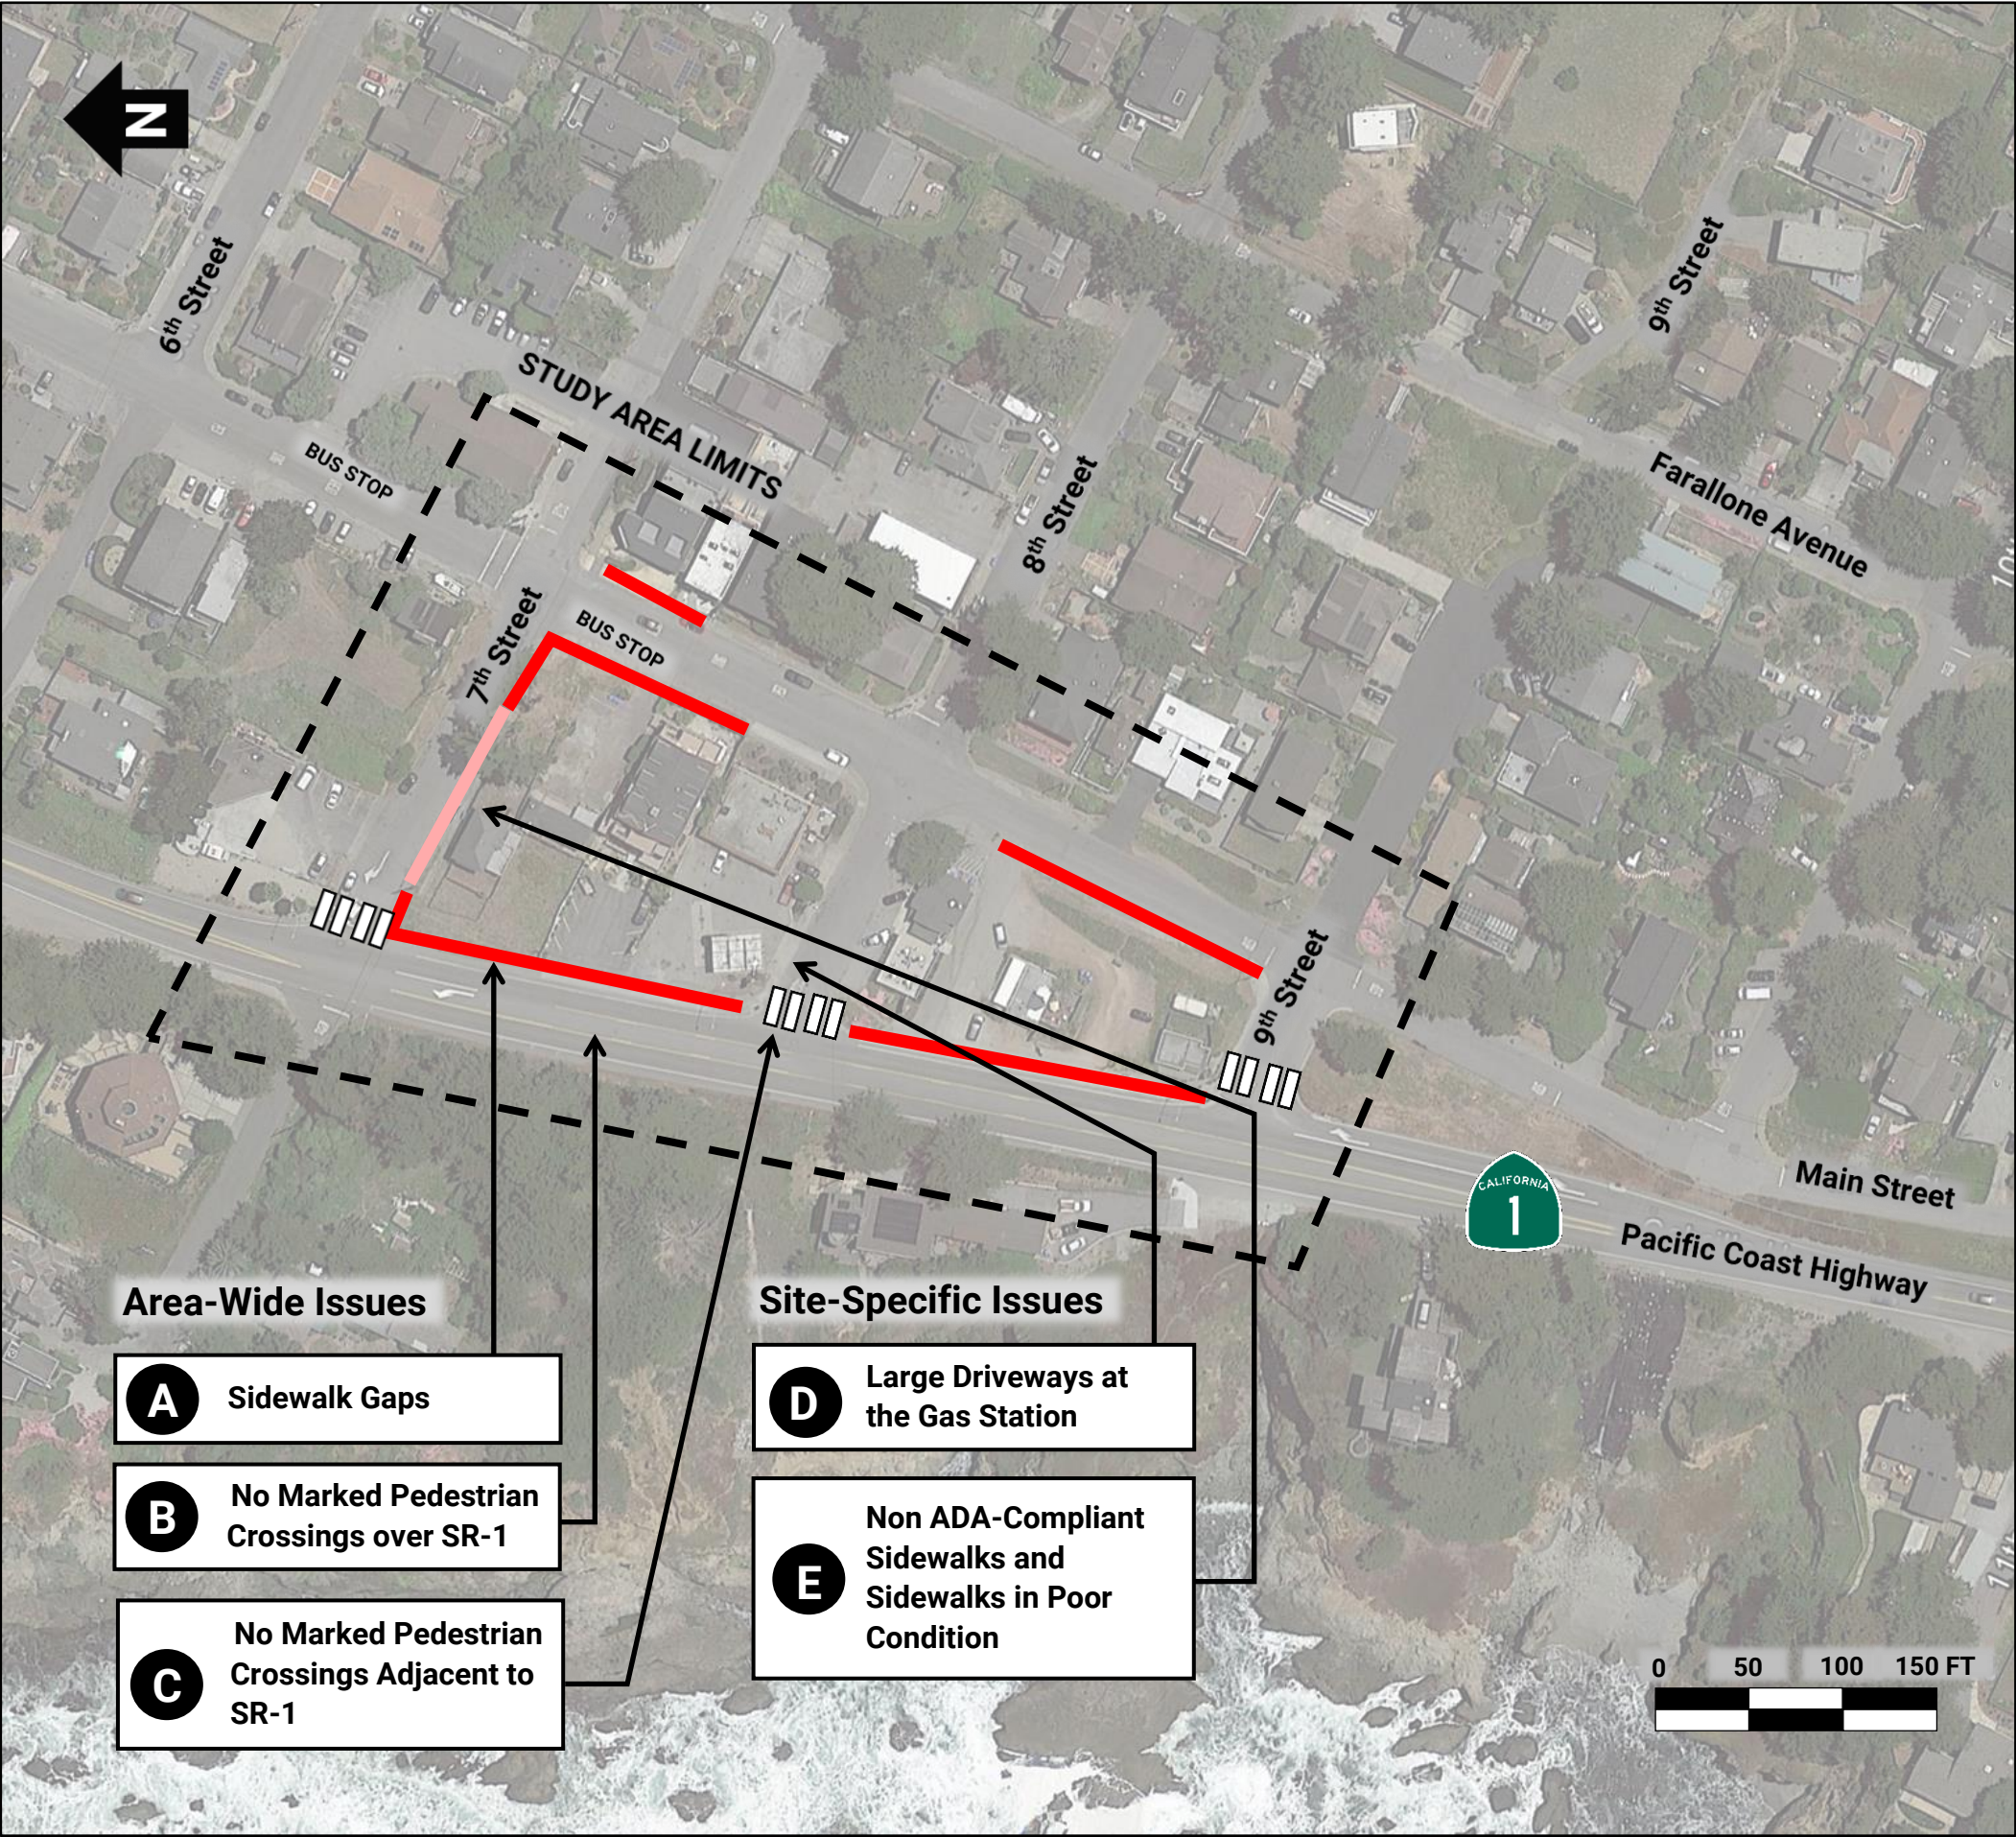
**Figure 3**  
**Study Area 2: Downtown Montara**  
Montara, CA

| | Issue | Recommendation |
|---|---|---|
| <b>A</b><br> | <b>Sidewalk gaps</b> result in a disconnected and inaccessible downtown walking network. | <b>Short-Term</b> <ul style="list-style-type: none"><li>Install vertical separation (e.g., wooden curb stops) to delineate travel lane from paved shoulder in areas without existing sidewalk infrastructure</li></ul> <b>Long-Term</b> <ul style="list-style-type: none"><li>Install concrete sidewalks in areas without existing sidewalk infrastructure that abut existing concrete sidewalks</li></ul> |
| <b>B</b> | <b>No marked pedestrian crossings over SR-1</b> result in Montara being disconnected from the coastline and development on the west side of SR-1. | See the forthcoming Caltrans District 4 Pedestrian Plan for additional opportunities for pedestrian facilities along and across Caltrans right-of-way.<br><br>See Highway 1 Safety and Mobility Study Phase 2 for additional long-term recommendations for pedestrian facilities along SR-1 and within Downtown Montara:<br><a href="http://planning.smcgov.org/sites/planning.smcgov.org/files/SMM_Ph_2_Study_Final_LR.pdf">planning.smcgov.org/sites/planning.smcgov.org/files/SMM_Ph_2_Study_Final_LR.pdf</a> |
| <b>C</b> | <b>No marked pedestrian crossings adjacent to SR-1</b> result in lower pedestrian visibility for high-speed vehicles turning off of SR-1. | <b>Long-Term</b> <ul style="list-style-type: none"><li>Install marked crosswalks at 7<sup>th</sup>, 8<sup>th</sup>, and 9<sup>th</sup> Streets</li><li>Install accessible landing pads at ends of marked crosswalks</li></ul> |
| <b>D</b> | <b>Large driveways at the gas station</b> create additional pedestrian/vehicle conflict zones. | <b>Long-Term</b> <ul style="list-style-type: none"><li>Remove eastern gas station driveway on 8<sup>th</sup> Street and reduce widths of remaining driveways to reduce speeds of vehicles turning into gas station (requires coordination with property owner)</li></ul> |
| <b>E</b><br> | <b>Non ADA-compliant sidewalks and sidewalks in poor condition</b> make walking less enjoyable and are a barrier to pedestrian access. | <b>Short-Term</b> <ul style="list-style-type: none"><li>Conduct regular sidewalk maintenance</li></ul> <b>Long-Term</b> <ul style="list-style-type: none"><li>Repair damaged sidewalks and construct accessible landings at intersections</li></ul> |

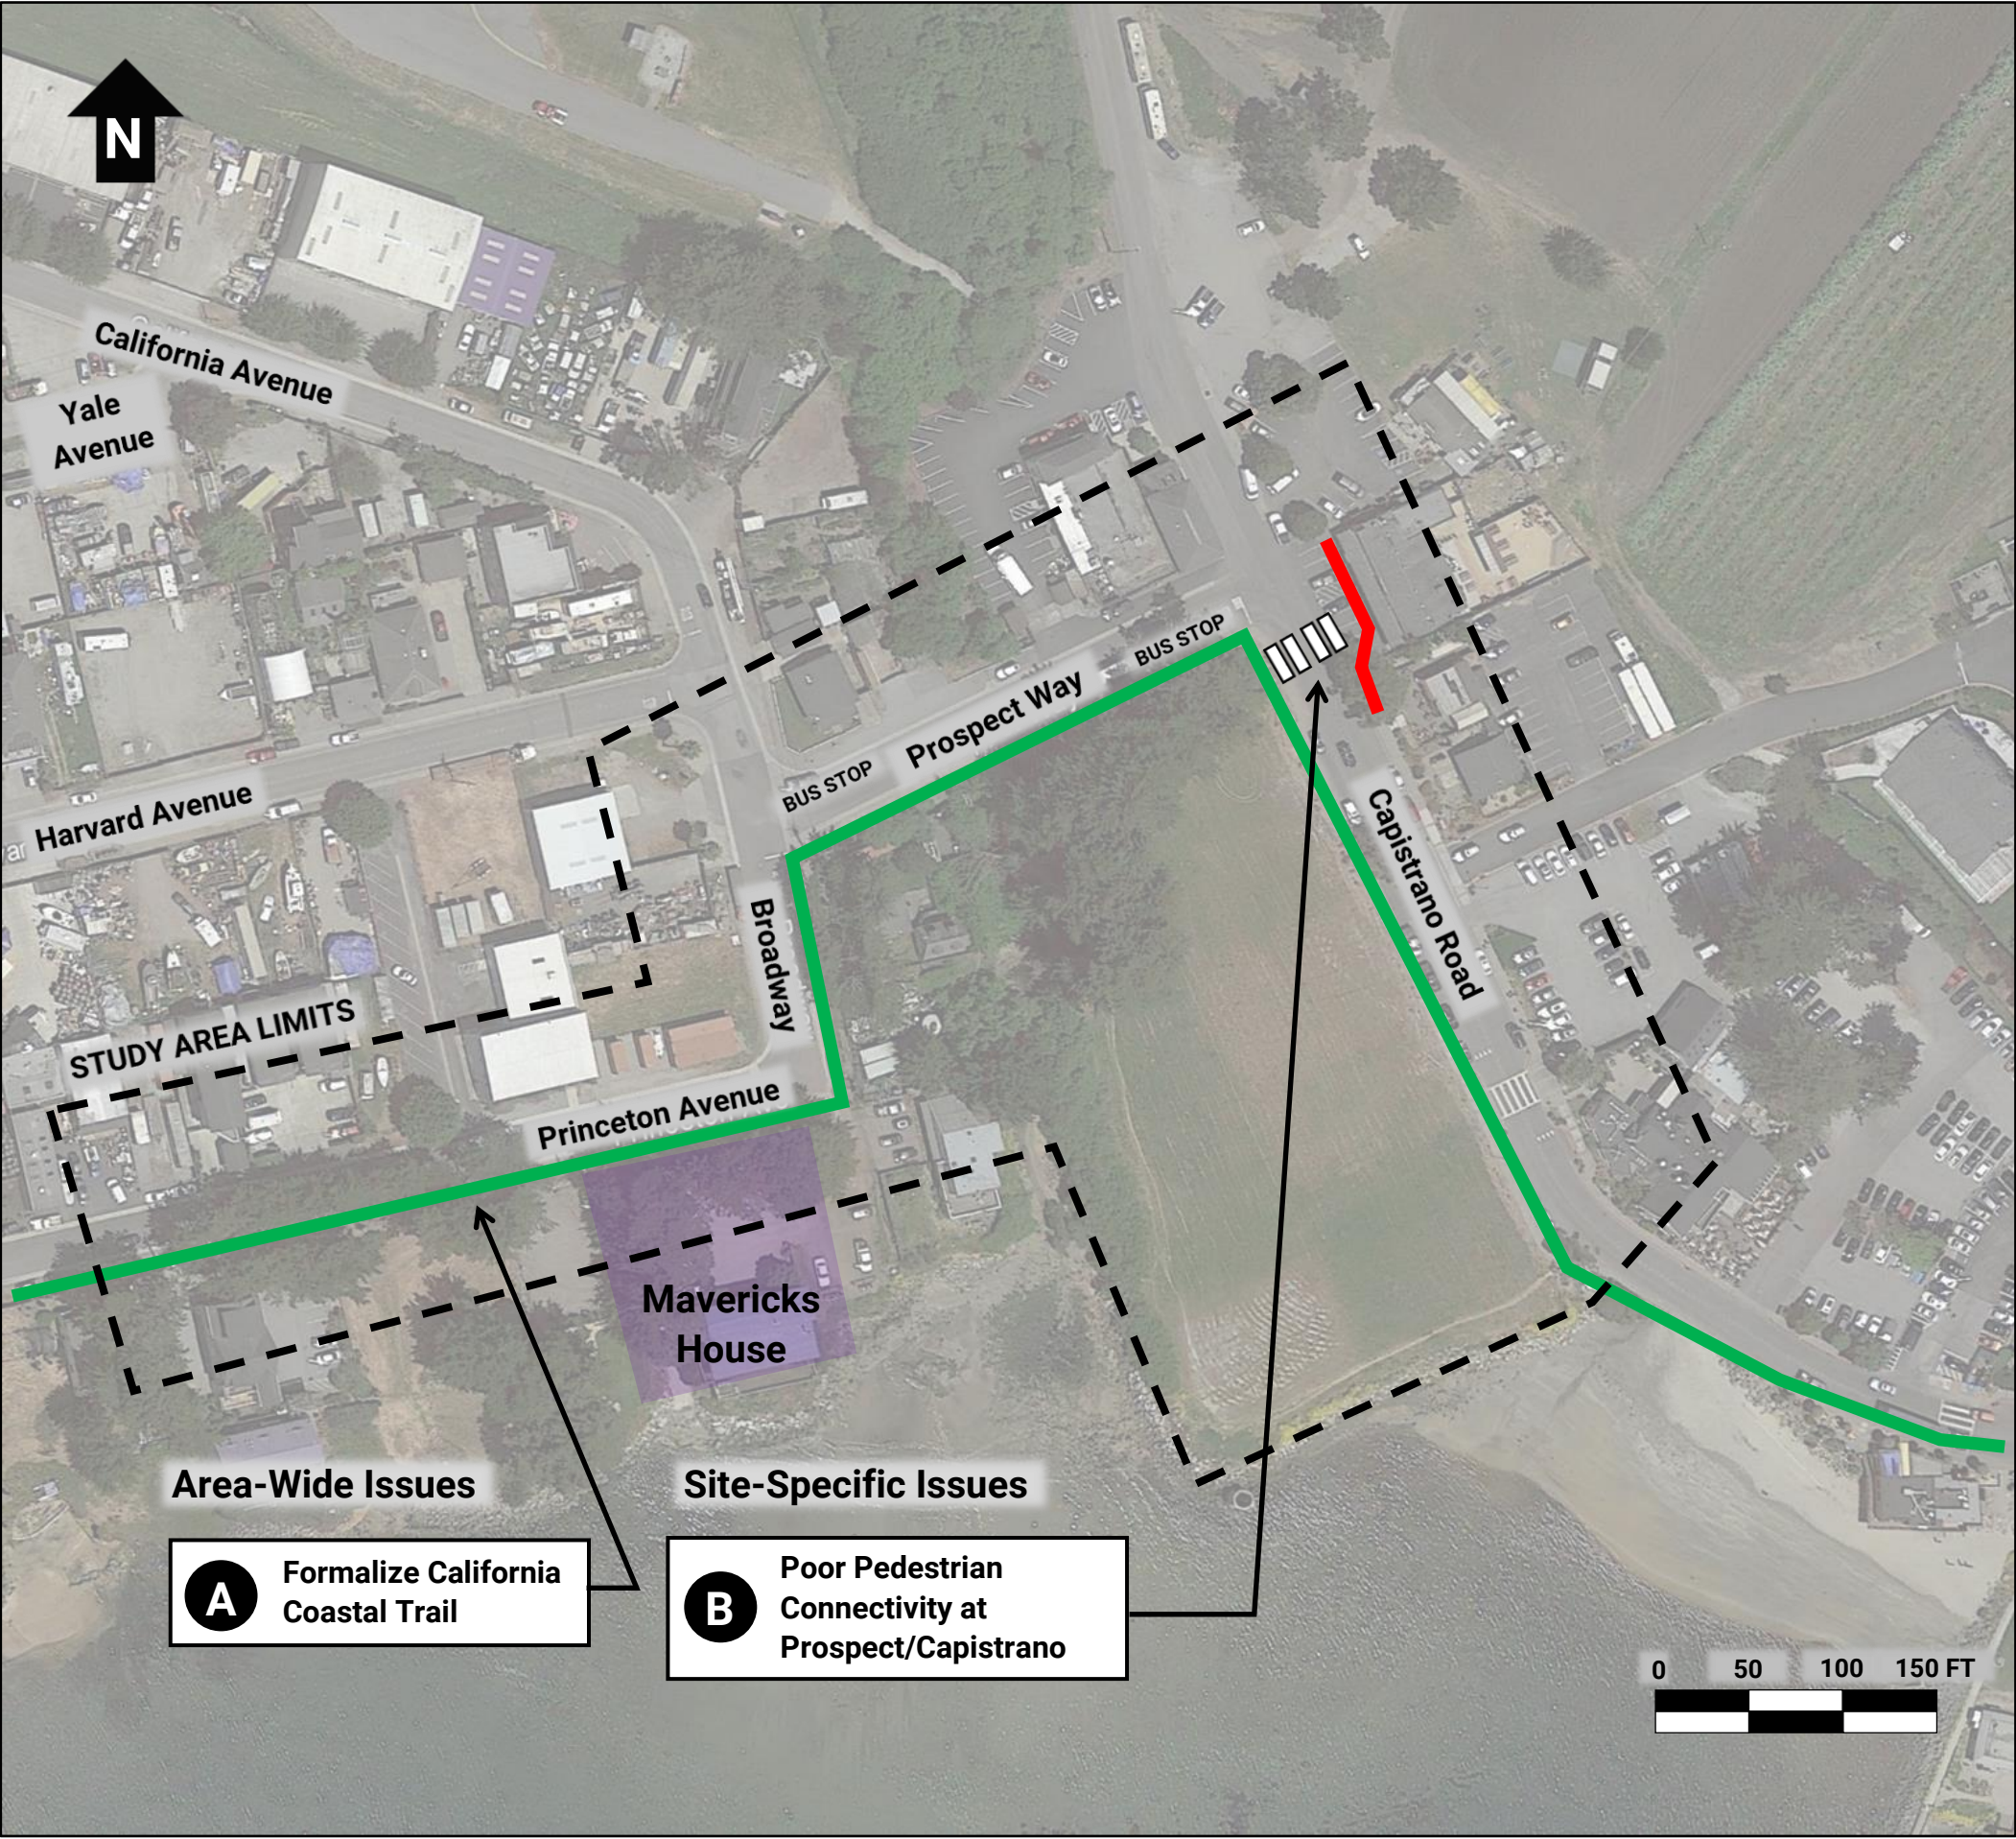
**Figure 4**  
**Study Area 3: Mavericks House Event Center**  
Princeton, CA

| | Issue | Recommendation |
|---|---|---|
| A | <b>Formalize the California Coastal Trail</b> by adding wayfinding and lighting to make it more comfortable and intuitive to navigate. | <b>Short-Term</b> <ul style="list-style-type: none"><li>Install wayfinding signage along trail</li></ul> <b>Long-Term</b> <ul style="list-style-type: none"><li>Add pedestrian-scale lighting along the California Coastal Trail in Princeton and in vicinity of Event Center</li></ul> |
| B | <b>Poor pedestrian connectivity at the Prospect/Capistrano intersection</b> creates a safety and access issue for pedestrians going to local businesses. | <b>Short-Term</b> <ul style="list-style-type: none"><li>Install stop signs and stop bars on Capistrano Road at Prospect Way to create three-way stop-controlled intersection</li><li>Formalize a walkway behind parking spaces in front of the Old Princeton Landing Pub &amp; Grill</li></ul> <b>Long-Term</b> <ul style="list-style-type: none"><li>Install a marked crosswalk and curb ramps on the eastern leg of the Prospect/Capistrano intersection to provide connectivity across Capistrano (requires coordination with property owner)</li></ul> |

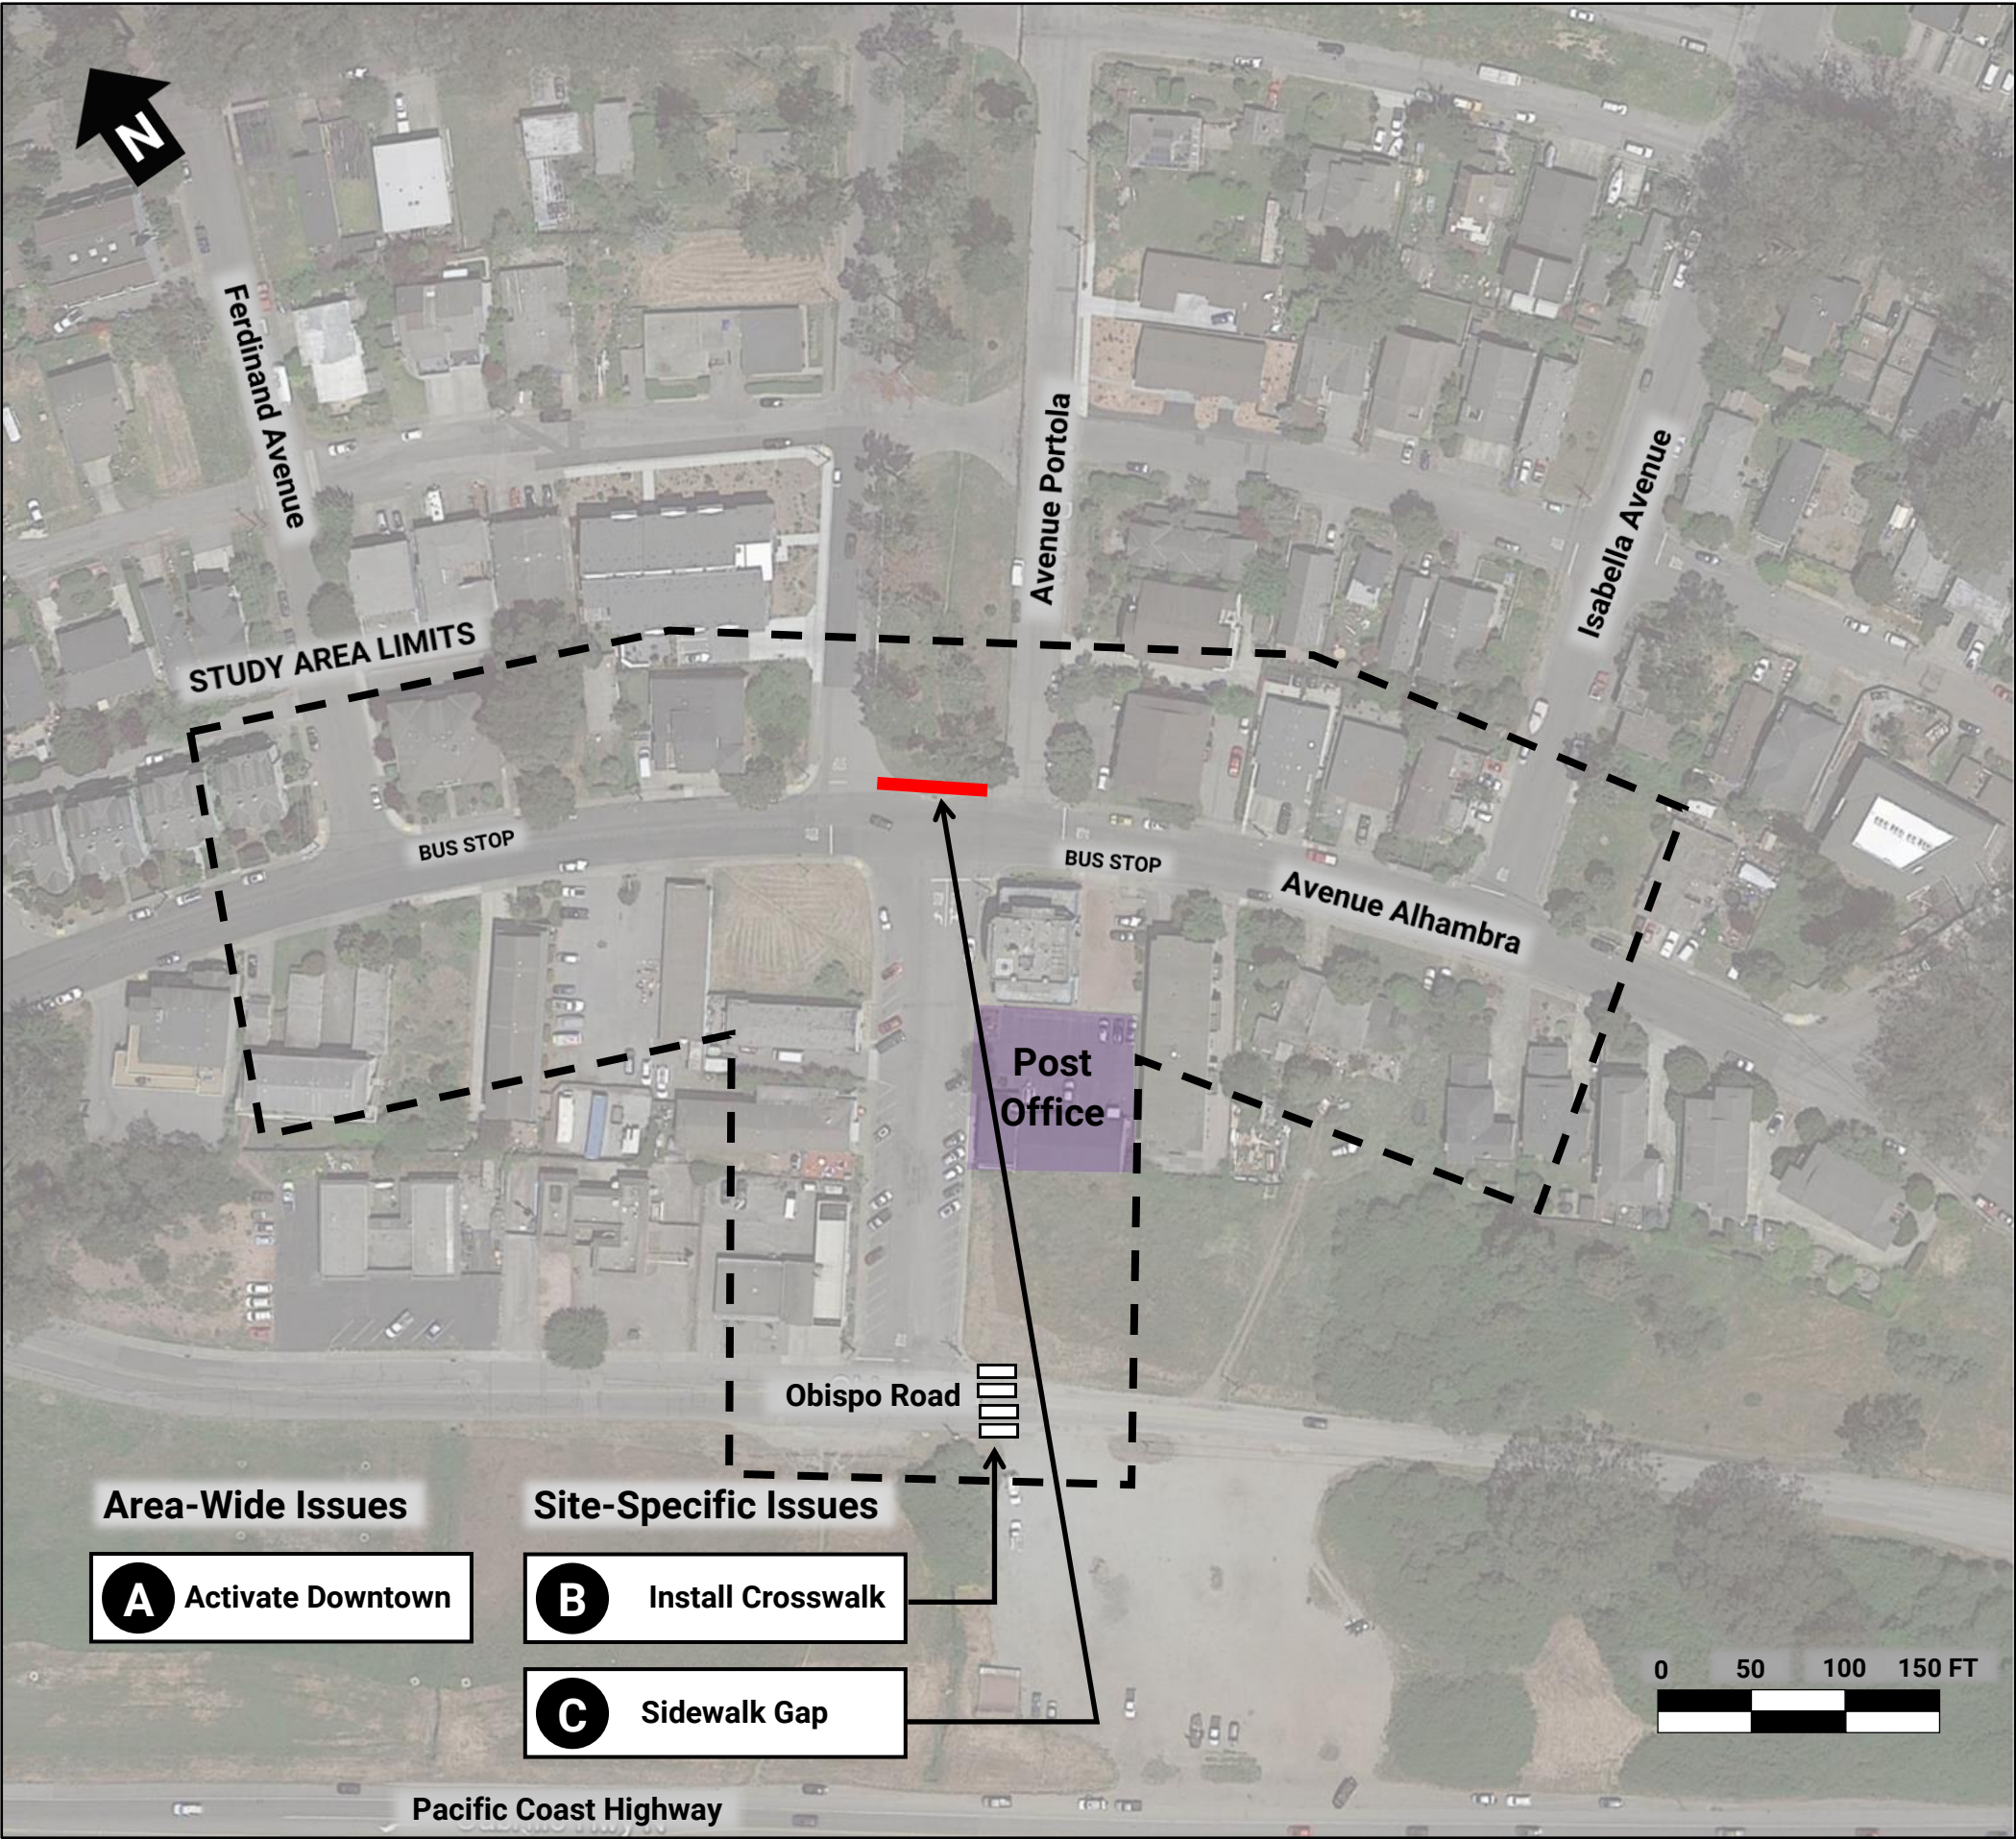
**Figure 5**  
**Study Area 4: Downtown El Granada**  
El Granada, CA

| | Issue | Recommendation |
|---|---|---|
| A | <b>Activate downtown</b> , which is currently automobile-focused. | <b>Short-Term</b> <ul style="list-style-type: none"><li>Seal coat existing parking lanes on Avenue Portola from Avenue Alhambra to Obispo Road with colored patterns to visually narrow roadway and delineate parking lanes from travel lanes</li><li>Convert several parking spaces to planters or parklets to activate El Granada's downtown</li></ul> <b>Long-Term</b> <ul style="list-style-type: none"><li>Reconstruct Avenue Portola from Avenue Alhambra to Obispo Road with wider sidewalks, street trees, and a narrower curb-to-curb street width</li></ul> |
| B | <b>Install crosswalk</b> on Obispo Road to connect southern parking lot to downtown businesses. | <b>Short-Term</b> <ul style="list-style-type: none"><li>Install crosswalk on southeastern leg of Obispo/Portola intersection</li></ul> |
| C | <b>Sidewalk gap</b> at Portola/Alhambra intersection. | <b>Long-Term</b> <ul style="list-style-type: none"><li>Install concrete sidewalk and curb ramps</li></ul> |

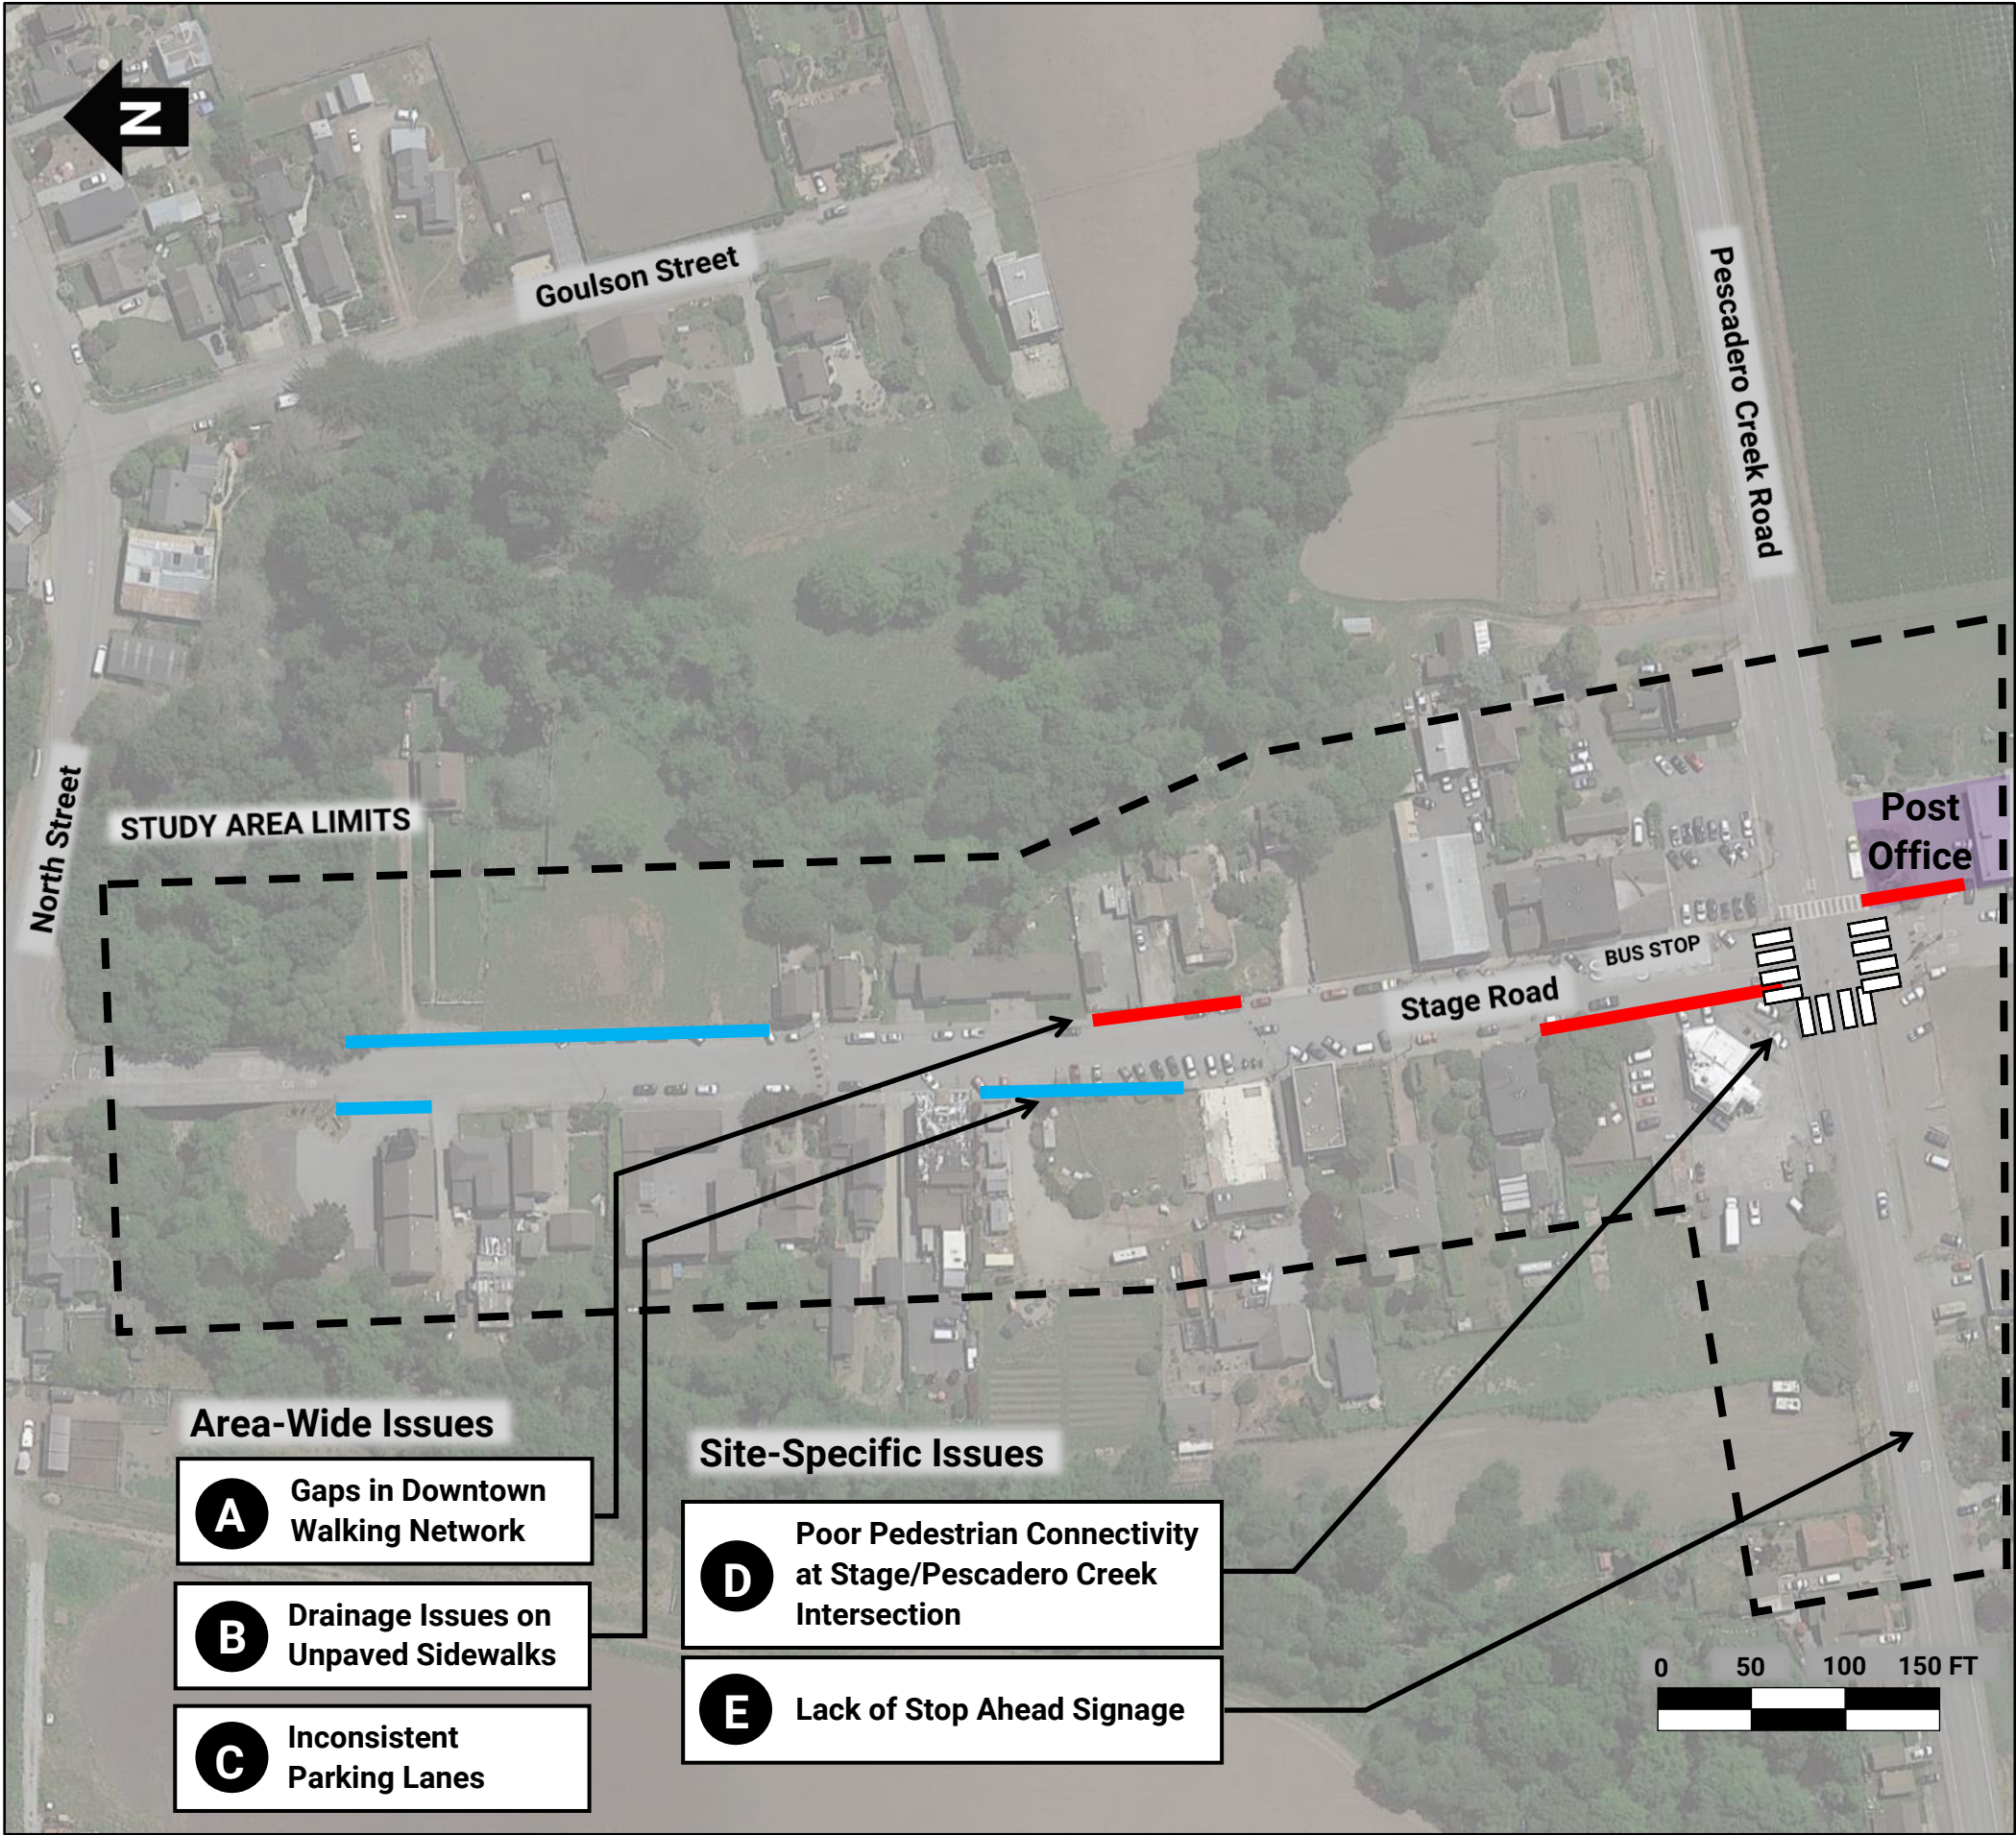
**Figure 6**  
**Study Area 5: Downtown Pescadero**  
Pescadero, CA

| | Issue | Recommendation |
|---|---|---|
| A | <b>Gaps in downtown walking network</b> limit pedestrian connectivity in downtown Pescadero. | <b>Short-Term</b> <ul style="list-style-type: none"><li>Install vertical separation (e.g., wooden curb stops) to delineate unpaved shoulder parking lane from existing unpaved walkways</li><li>Extend sidepath from Stage/Pescadero Creek intersection to Post Office</li></ul> <b>Long-Term</b> <ul style="list-style-type: none"><li>Install concrete sidewalks in front of Topia Antiques and gas station (areas without existing sidewalk infrastructure that abut existing concrete sidewalks)</li></ul> |
| B | <b>Drainage issues on unpaved sidewalks</b> after rain events. | <b>Short-Term</b> <ul style="list-style-type: none"><li>Conduct regular sidewalk maintenance (i.e., fill depressions with new soil)</li></ul> <b>Long-Term</b> <ul style="list-style-type: none"><li>Install crushed gravel to reinforce and level unpaved walkways</li></ul> |
| C | <b>Inconsistent parking lanes</b> result in disorganized vehicle parking and vehicles encroaching in pedestrian space. | <b>Short-Term:</b> <ul style="list-style-type: none"><li>Reconfigure parking on each side of Stage Road to be consistent (i.e., all parallel or all diagonal) by striping parking spaces</li></ul> |
| D | <b>Poor pedestrian connectivity at the Stage/Pescadero Creek intersection</b> creates a safety and access issue for pedestrians going to the Post Office and other destinations to the south. | <b>Short-Term</b> <ul style="list-style-type: none"><li>Install high-visibility crosswalks on all four legs of the intersection</li></ul> <b>Long-Term</b> <ul style="list-style-type: none"><li>Install lighting at intersection to illuminate crosswalks</li></ul> |
| E | <b>Lack of Stop Ahead Signage</b> on Pescadero Creek Road on eastbound approach to Stage Road. | <b>Short-Term</b> <ul style="list-style-type: none"><li>Install Stop Ahead signage to augment existing Stop Ahead pavement markings</li></ul> |
