**Figure 2**  
**Study Area 1: Benjamin Franklin & Garden Village Schools**  
Broadmoor, CA

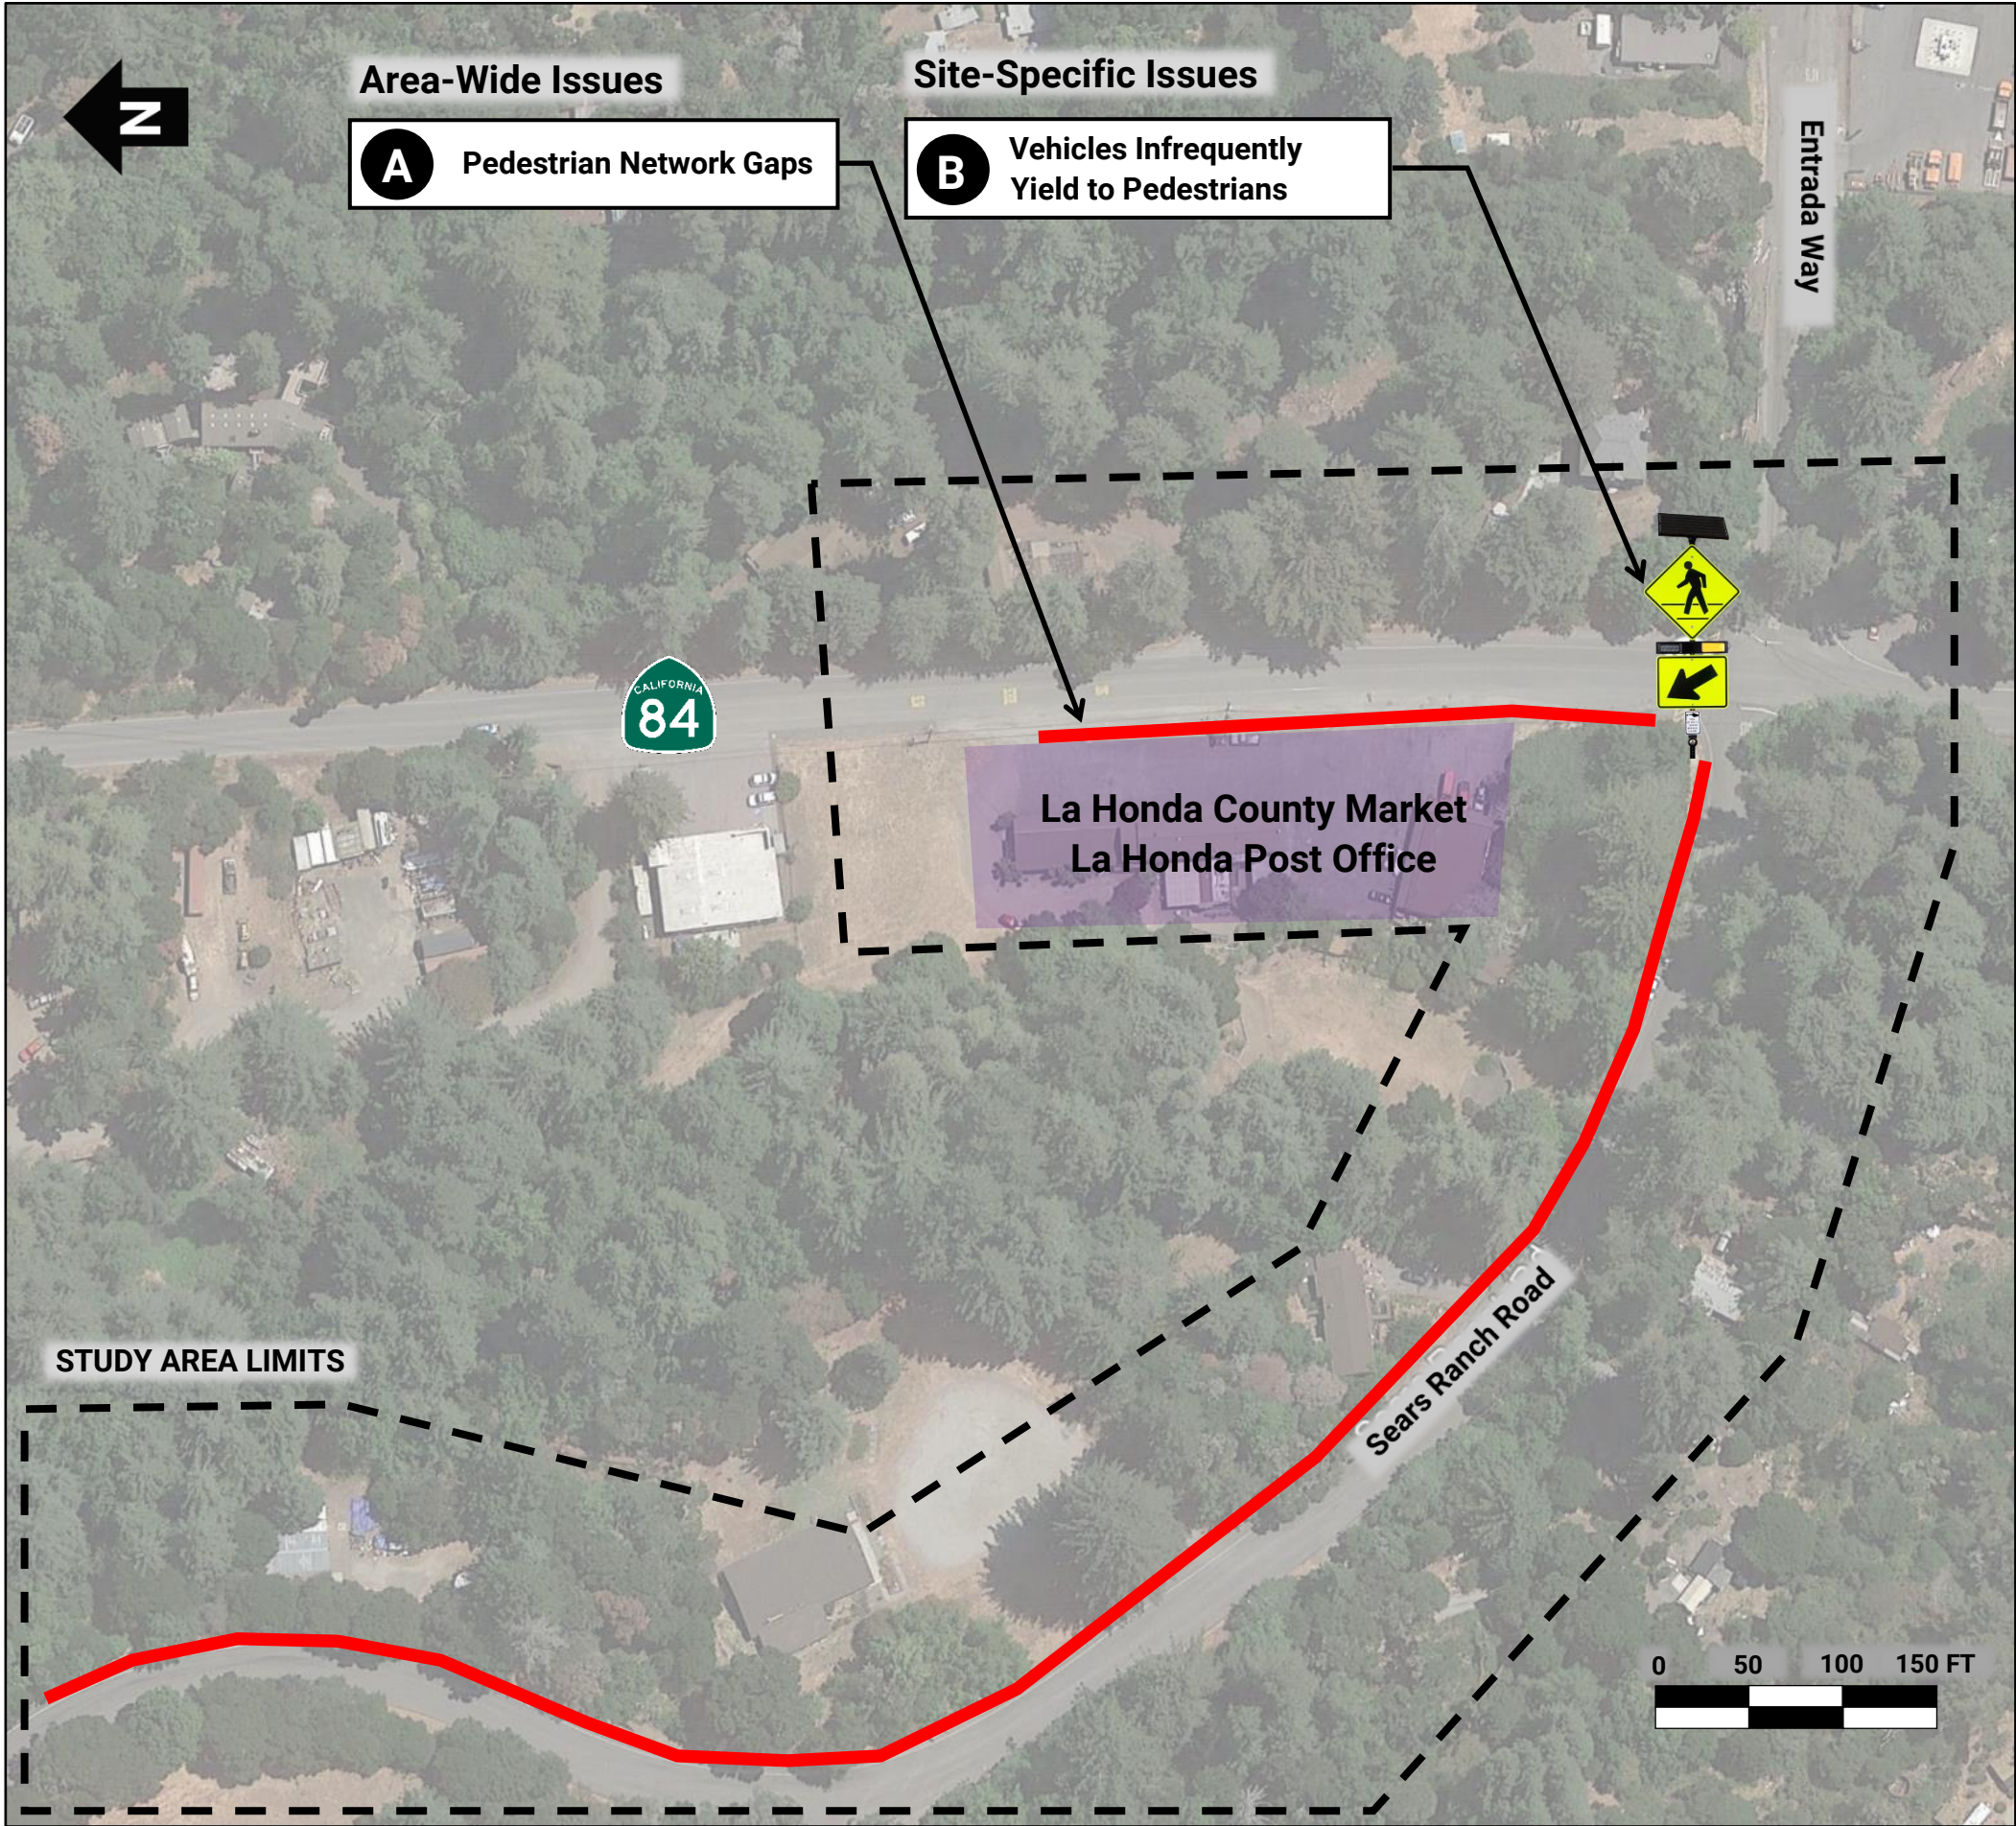
**Figure 7**  
**Study Area 6: Downtown La Honda**  
La Honda, CA

| | Issue | Recommendation |
|---|---|---|
| <b>A</b><br> | <b>Pedestrian network gaps</b> from the La Honda Country Market and Post Office to Sears Ranch Road and from La Honda Elementary School to SR-84 result in a disconnected and inaccessible walking network. | <b>Short-Term</b> <ul style="list-style-type: none"><li>Install vertical separation (e.g., wooden curb stops) on south side of SR-84 to delineate travel lane from paved shoulder walkway from Country Market to Sears Ranch Road</li><li>Install similar separation on east side of Sears Ranch Road from school to SR-84 to delineate travel lane from paved shoulder walkway. (This is also a recommendation from a San Mateo County Safe Routes to School walking audit conducted at La Honda Elementary School.)</li></ul> |
| <b>B</b> | <b>Vehicles infrequently yield to pedestrians</b> crossing SR-84 at Sears Ranch Road. | <b>Short-Term</b> <ul style="list-style-type: none"><li>Install pedestrian-activated rectangular rapid flashing beacons (RRFBs) at existing marked crossing to increase pedestrian conspicuity and priority. (This is also a recommendation from a San Mateo County Safe Routes to School walking audit conducted at La Honda Elementary School.)</li></ul> |

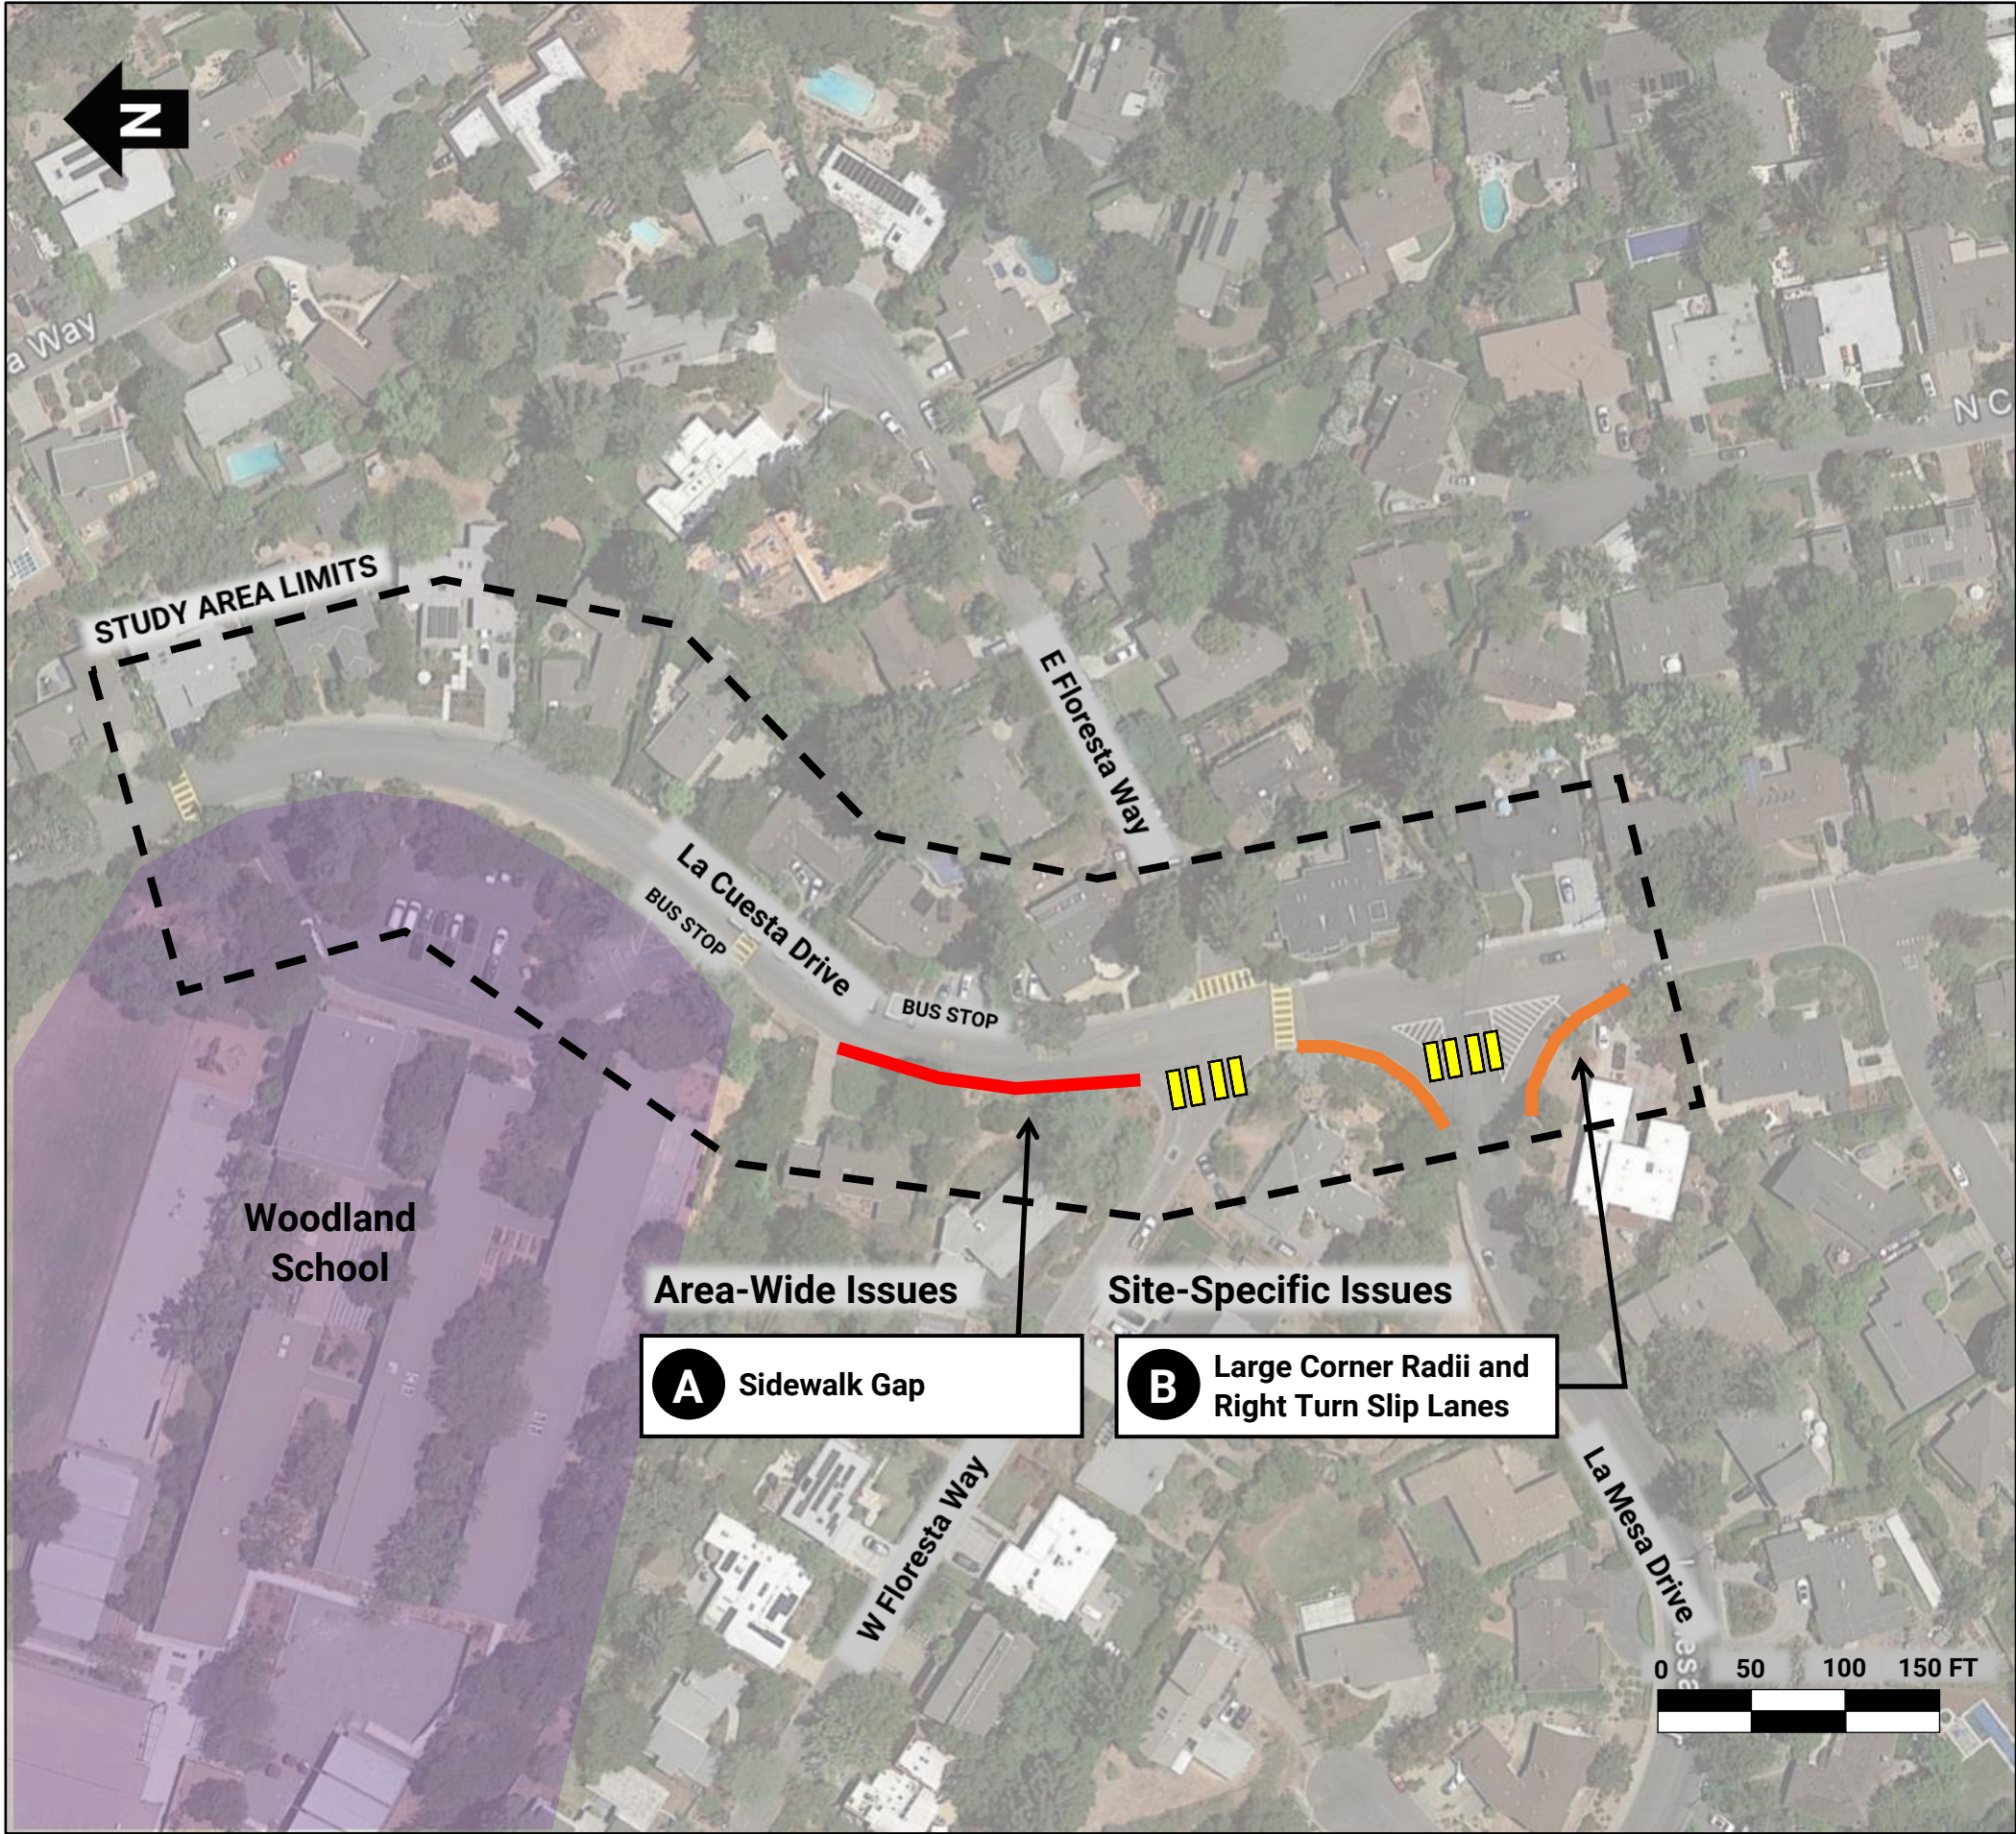
**Figure 8**  
**Study Area 7: Woodland School**  
Ladera, CA

| | Issue | Recommendation |
|---|---|---|
| A | <b>Sidewalk gap</b> results in disconnected walking network to access Woodland School from the south. | <b>Long-Term</b> <ul style="list-style-type: none"><li>• Install sidewalk on west side of La Cuesta Drive from West Floresta Way to existing sidewalk south of school entrance</li><li>• Install curb ramps and high-visibility school crosswalk across West Floresta Way</li></ul> |
| B | <b>Large corner radii and right turn slip lanes</b> result in high vehicle turning speeds and unsafe pedestrian crossing conditions at the intersection of La Cuesta Drive and La Mesa Drive. | <b>Short-Term</b> <ul style="list-style-type: none"><li>• Reduce intersection footprint by closing slip lanes and reducing corner radii, using quick-build temporary materials like paint and flexible delineators</li></ul> <b>Long-Term</b> <ul style="list-style-type: none"><li>• Reduce intersection footprint, close slip lanes, and reduce corner radii by reconstructing curblines.</li><li>• When reconstructing curblines, construct curb ramps and install marked crossing at intersection</li></ul> |

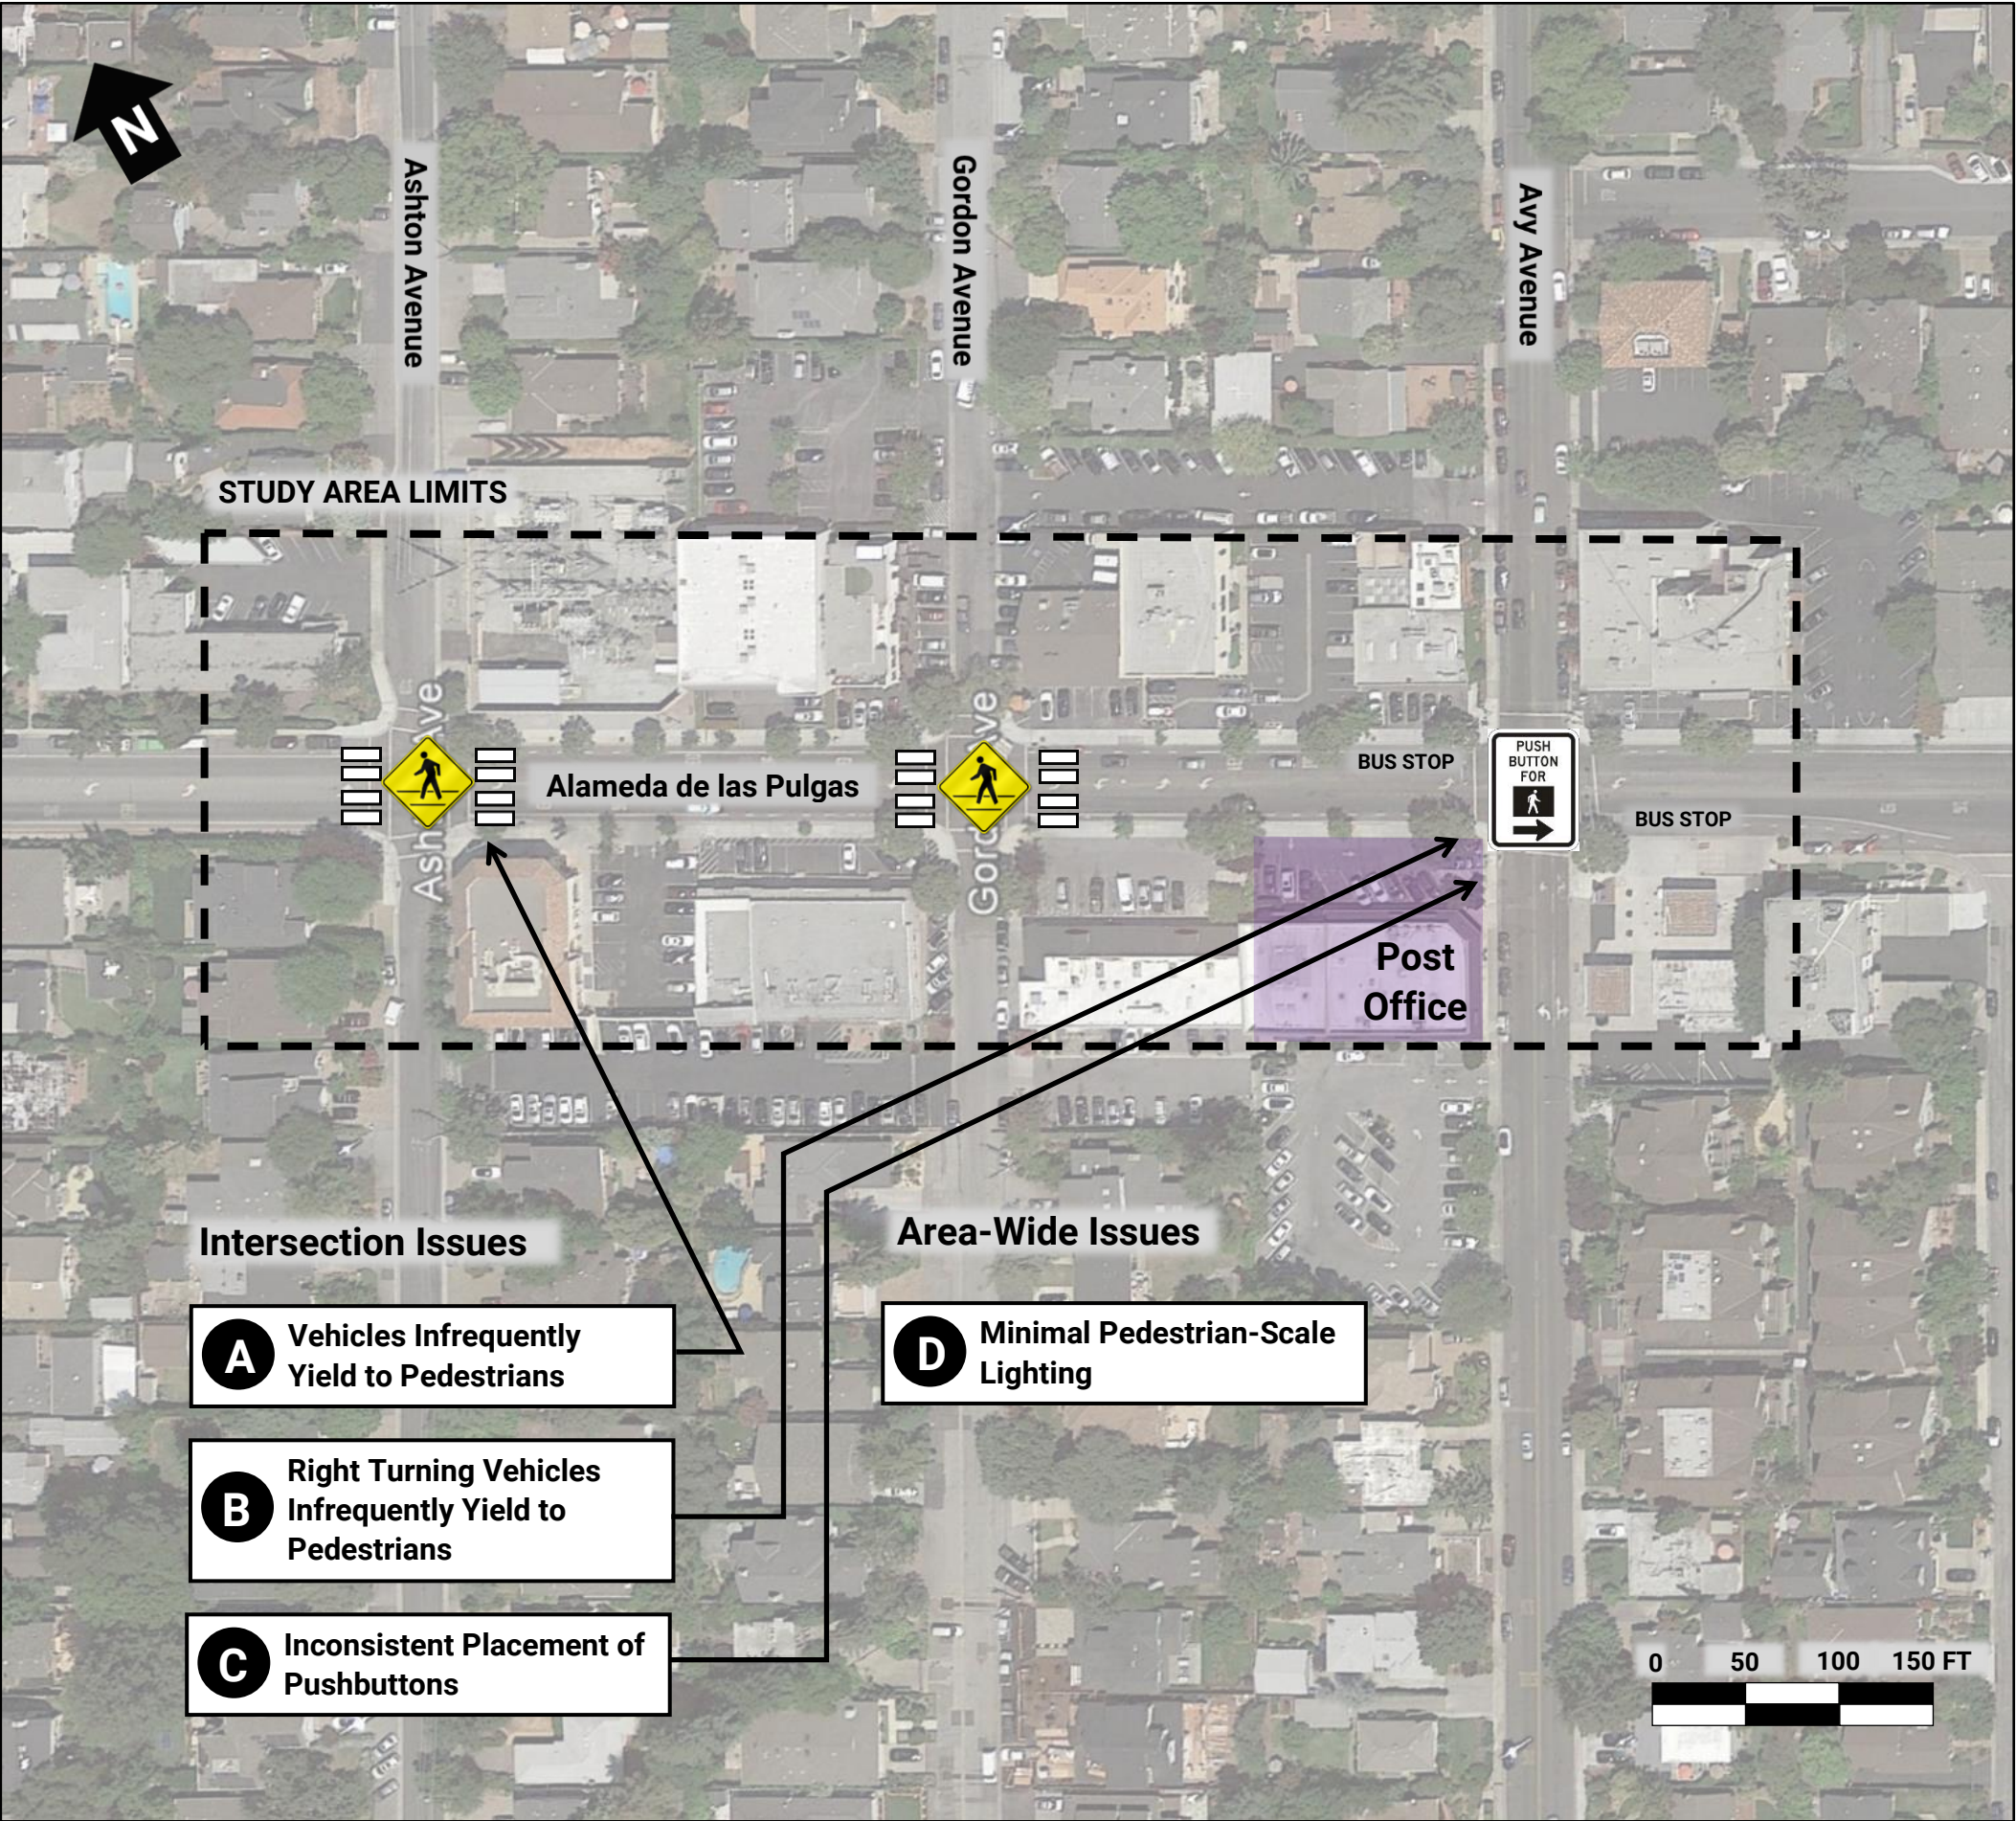
**Figure 9**  
**Study Area 8: Downtown West Menlo Park**  
West Menlo Park, CA

| | Issue | Recommendation |
|---|---|---|
| A | <b>Vehicles infrequently yield to pedestrians</b> crossing Alameda de las Pulgas at Ashton Avenue and Gordon Avenue. | <b>Short-Term</b> <ul style="list-style-type: none"><li>Upgrade existing marked crossings to high-visibility markings to increase pedestrian conspicuity and priority</li><li>Install pedestrian warning signage at crossings</li></ul> |
| B | <b>Right turning vehicles infrequently yield to pedestrians</b> , which results in an unattractive pedestrian environment. | <b>Short-Term</b> <ul style="list-style-type: none"><li>Install Leading Pedestrian Intervals (LPIs), which provide pedestrians with a walk indication 3 to 7 seconds before right turning vehicles traveling in the same direction receive a green indication, so pedestrians establish the right-of-way in the crosswalk</li></ul> |
| C | <b>Inconsistent placement of pushbuttons</b> results in non ADA-compliant crossings at the intersection of Alameda de las Pulgas and Avy Avenue. | <b>Long-Term</b> <ul style="list-style-type: none"><li>Relocate all pushbuttons (may require construction of new poles on which to place pushbuttons)</li></ul> |
| D | <b>Minimal pedestrian-scale lighting</b> along Alameda de las Pulgas results in an unattractive nighttime walking environment. | <b>Long-Term</b> <ul style="list-style-type: none"><li>Install pedestrian-scale lighting along Alameda de las Pulgas</li></ul> |

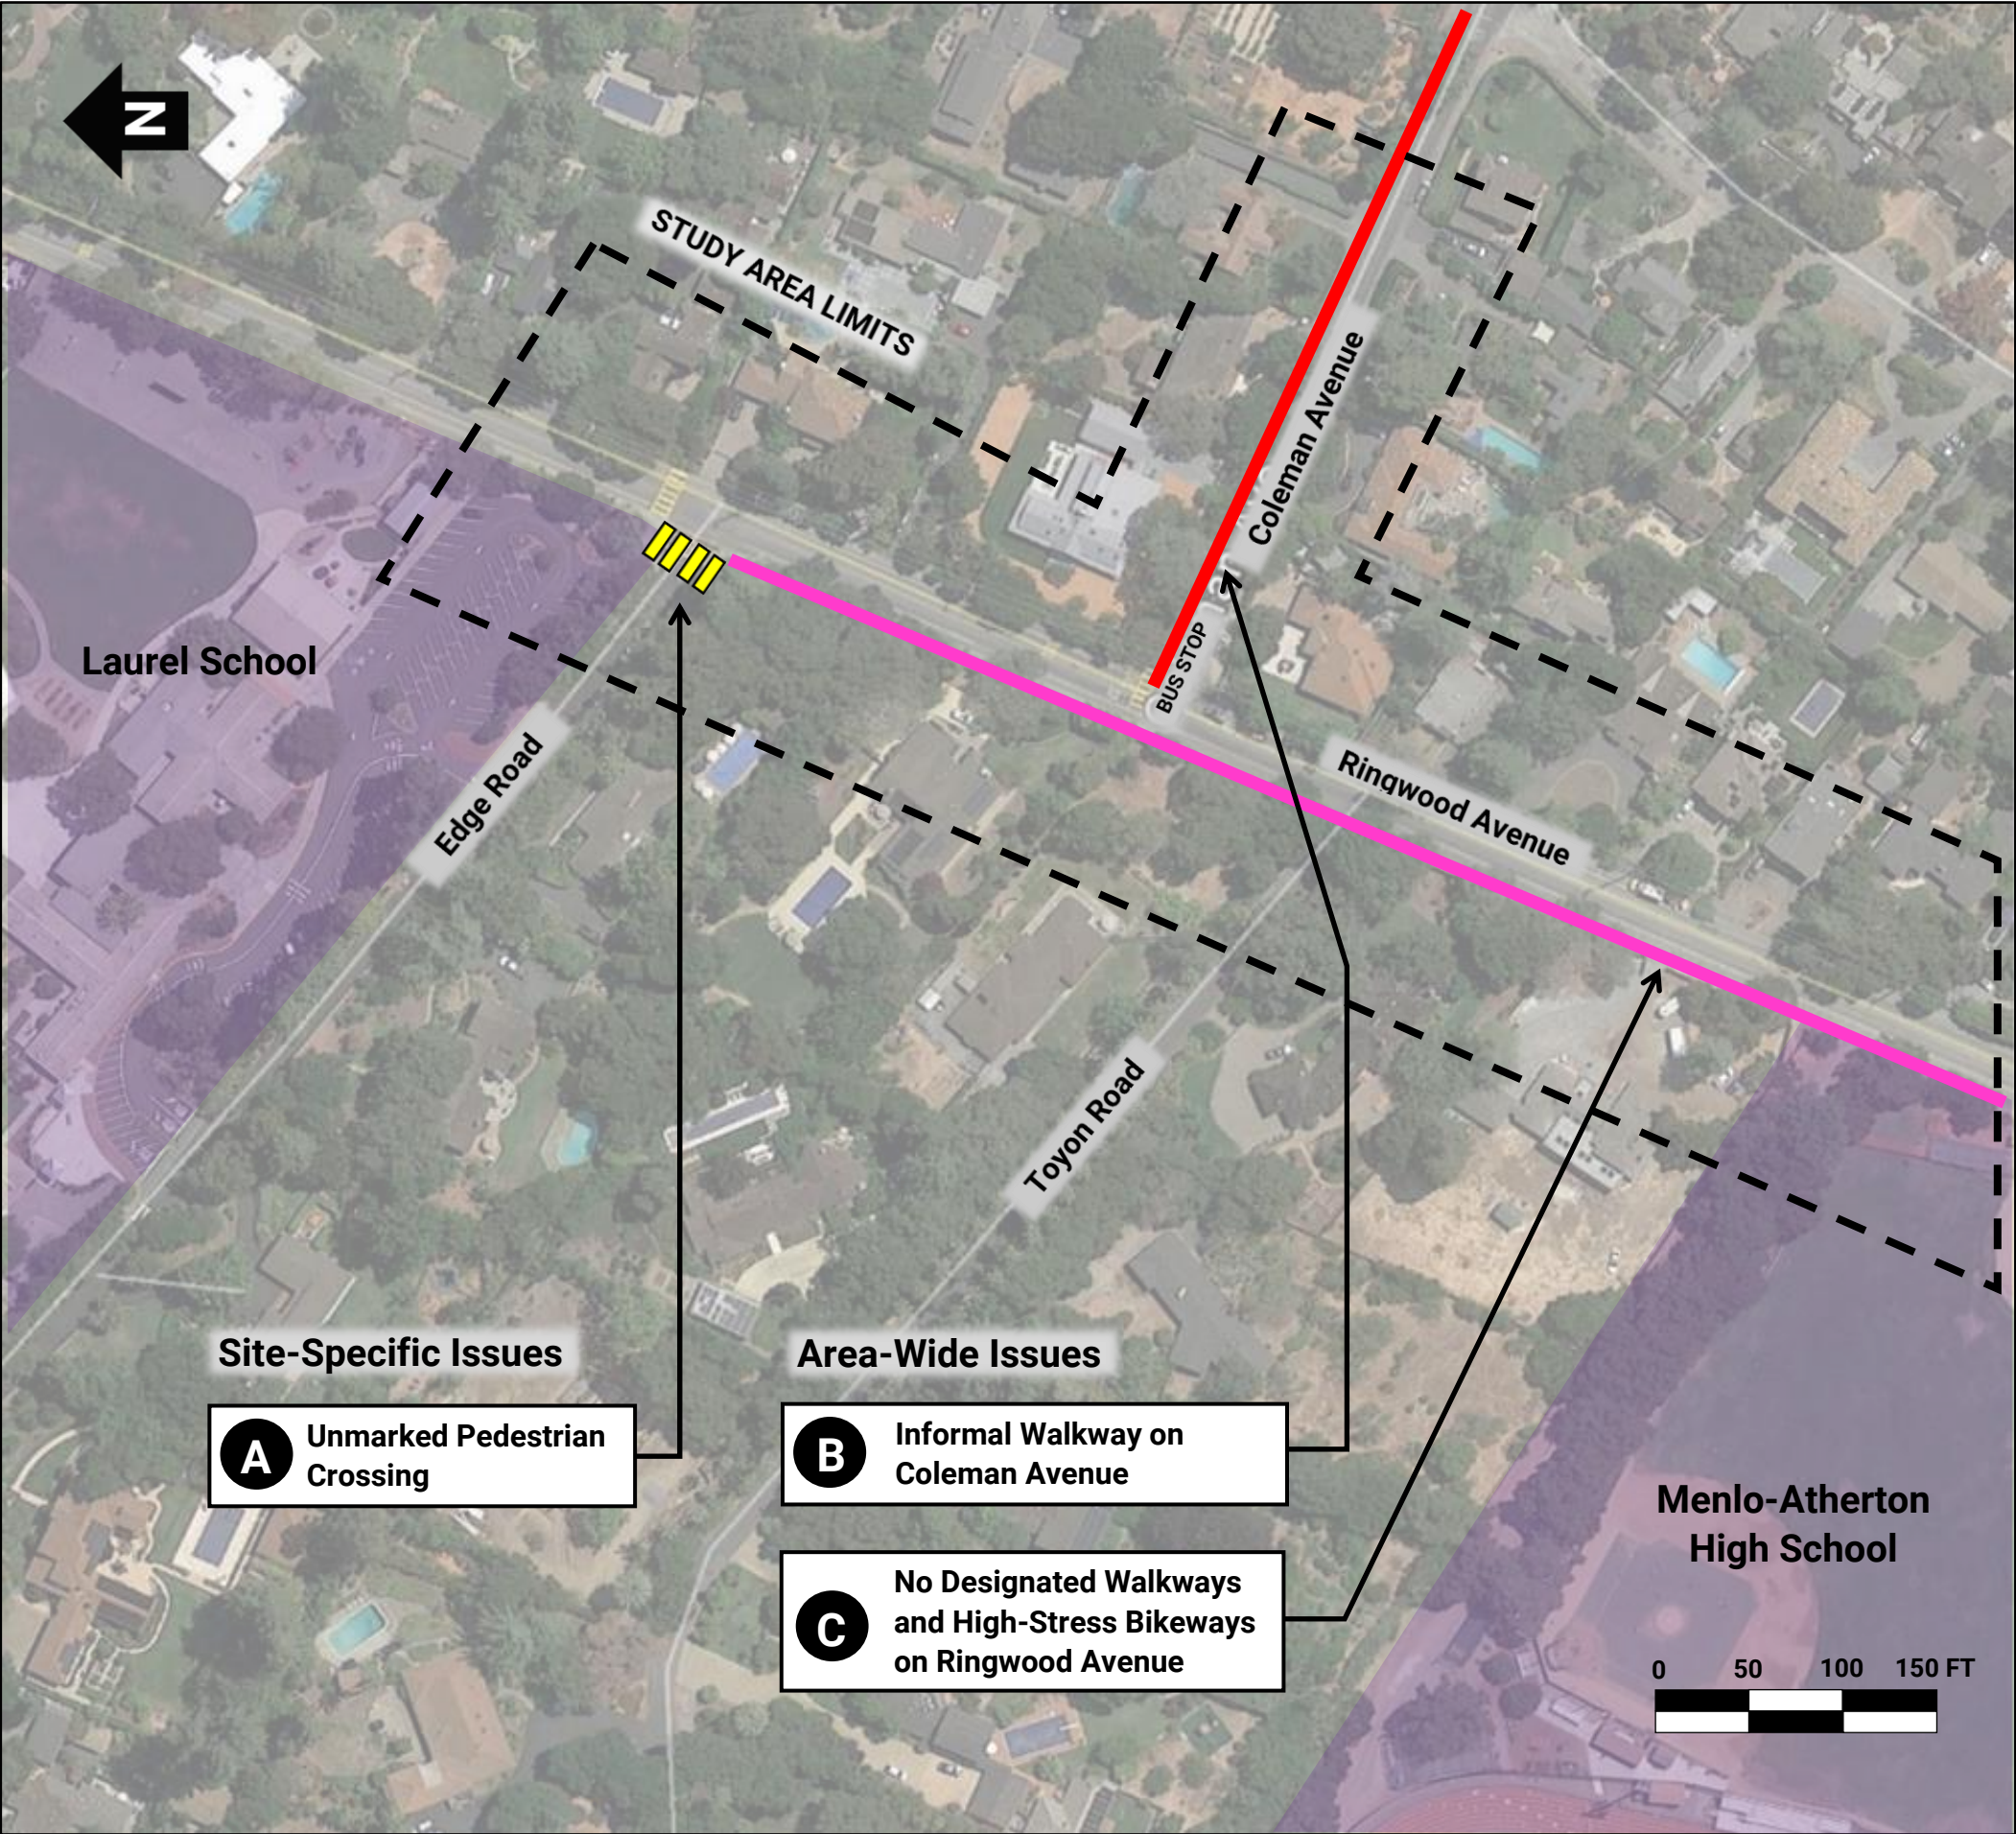
**Figure 10**  
**Study Area 9: Laurel School & Menlo-Atherton High**  
Menlo Oaks, CA

| | Issue | Recommendation |
|---|---|---|
| A | <b>Unmarked pedestrian crossing</b> at Edge Road, reducing pedestrian conspicuity for drivers. | <b>Short-Term</b> <ul style="list-style-type: none"><li>Restripe crosswalk over Edge Road</li></ul> |
| B | <b>Informal walkway on Coleman Avenue</b> , resulting in pedestrian safety and access issues. | <b>Short-Term</b> <ul style="list-style-type: none"><li>Formalize walkway on north side of Coleman Avenue by painting shoulder and/or installing vertical separation (e.g., wooden curb stops) to delineate shoulder walkway from travel lane</li></ul> |
| C | <b>No designated walkways and high-stress bikeways along Ringwood Avenue</b> , creating an unsafe walking and bicycling environment for students. | <b>Short-Term</b> <ul style="list-style-type: none"><li>Install shared-use path on west side of Ringwood Avenue using low cost materials like thermoplastic striping and curb stops to delineate it from the roadway (requires further study to determine impacts to existing infrastructure)</li></ul> |

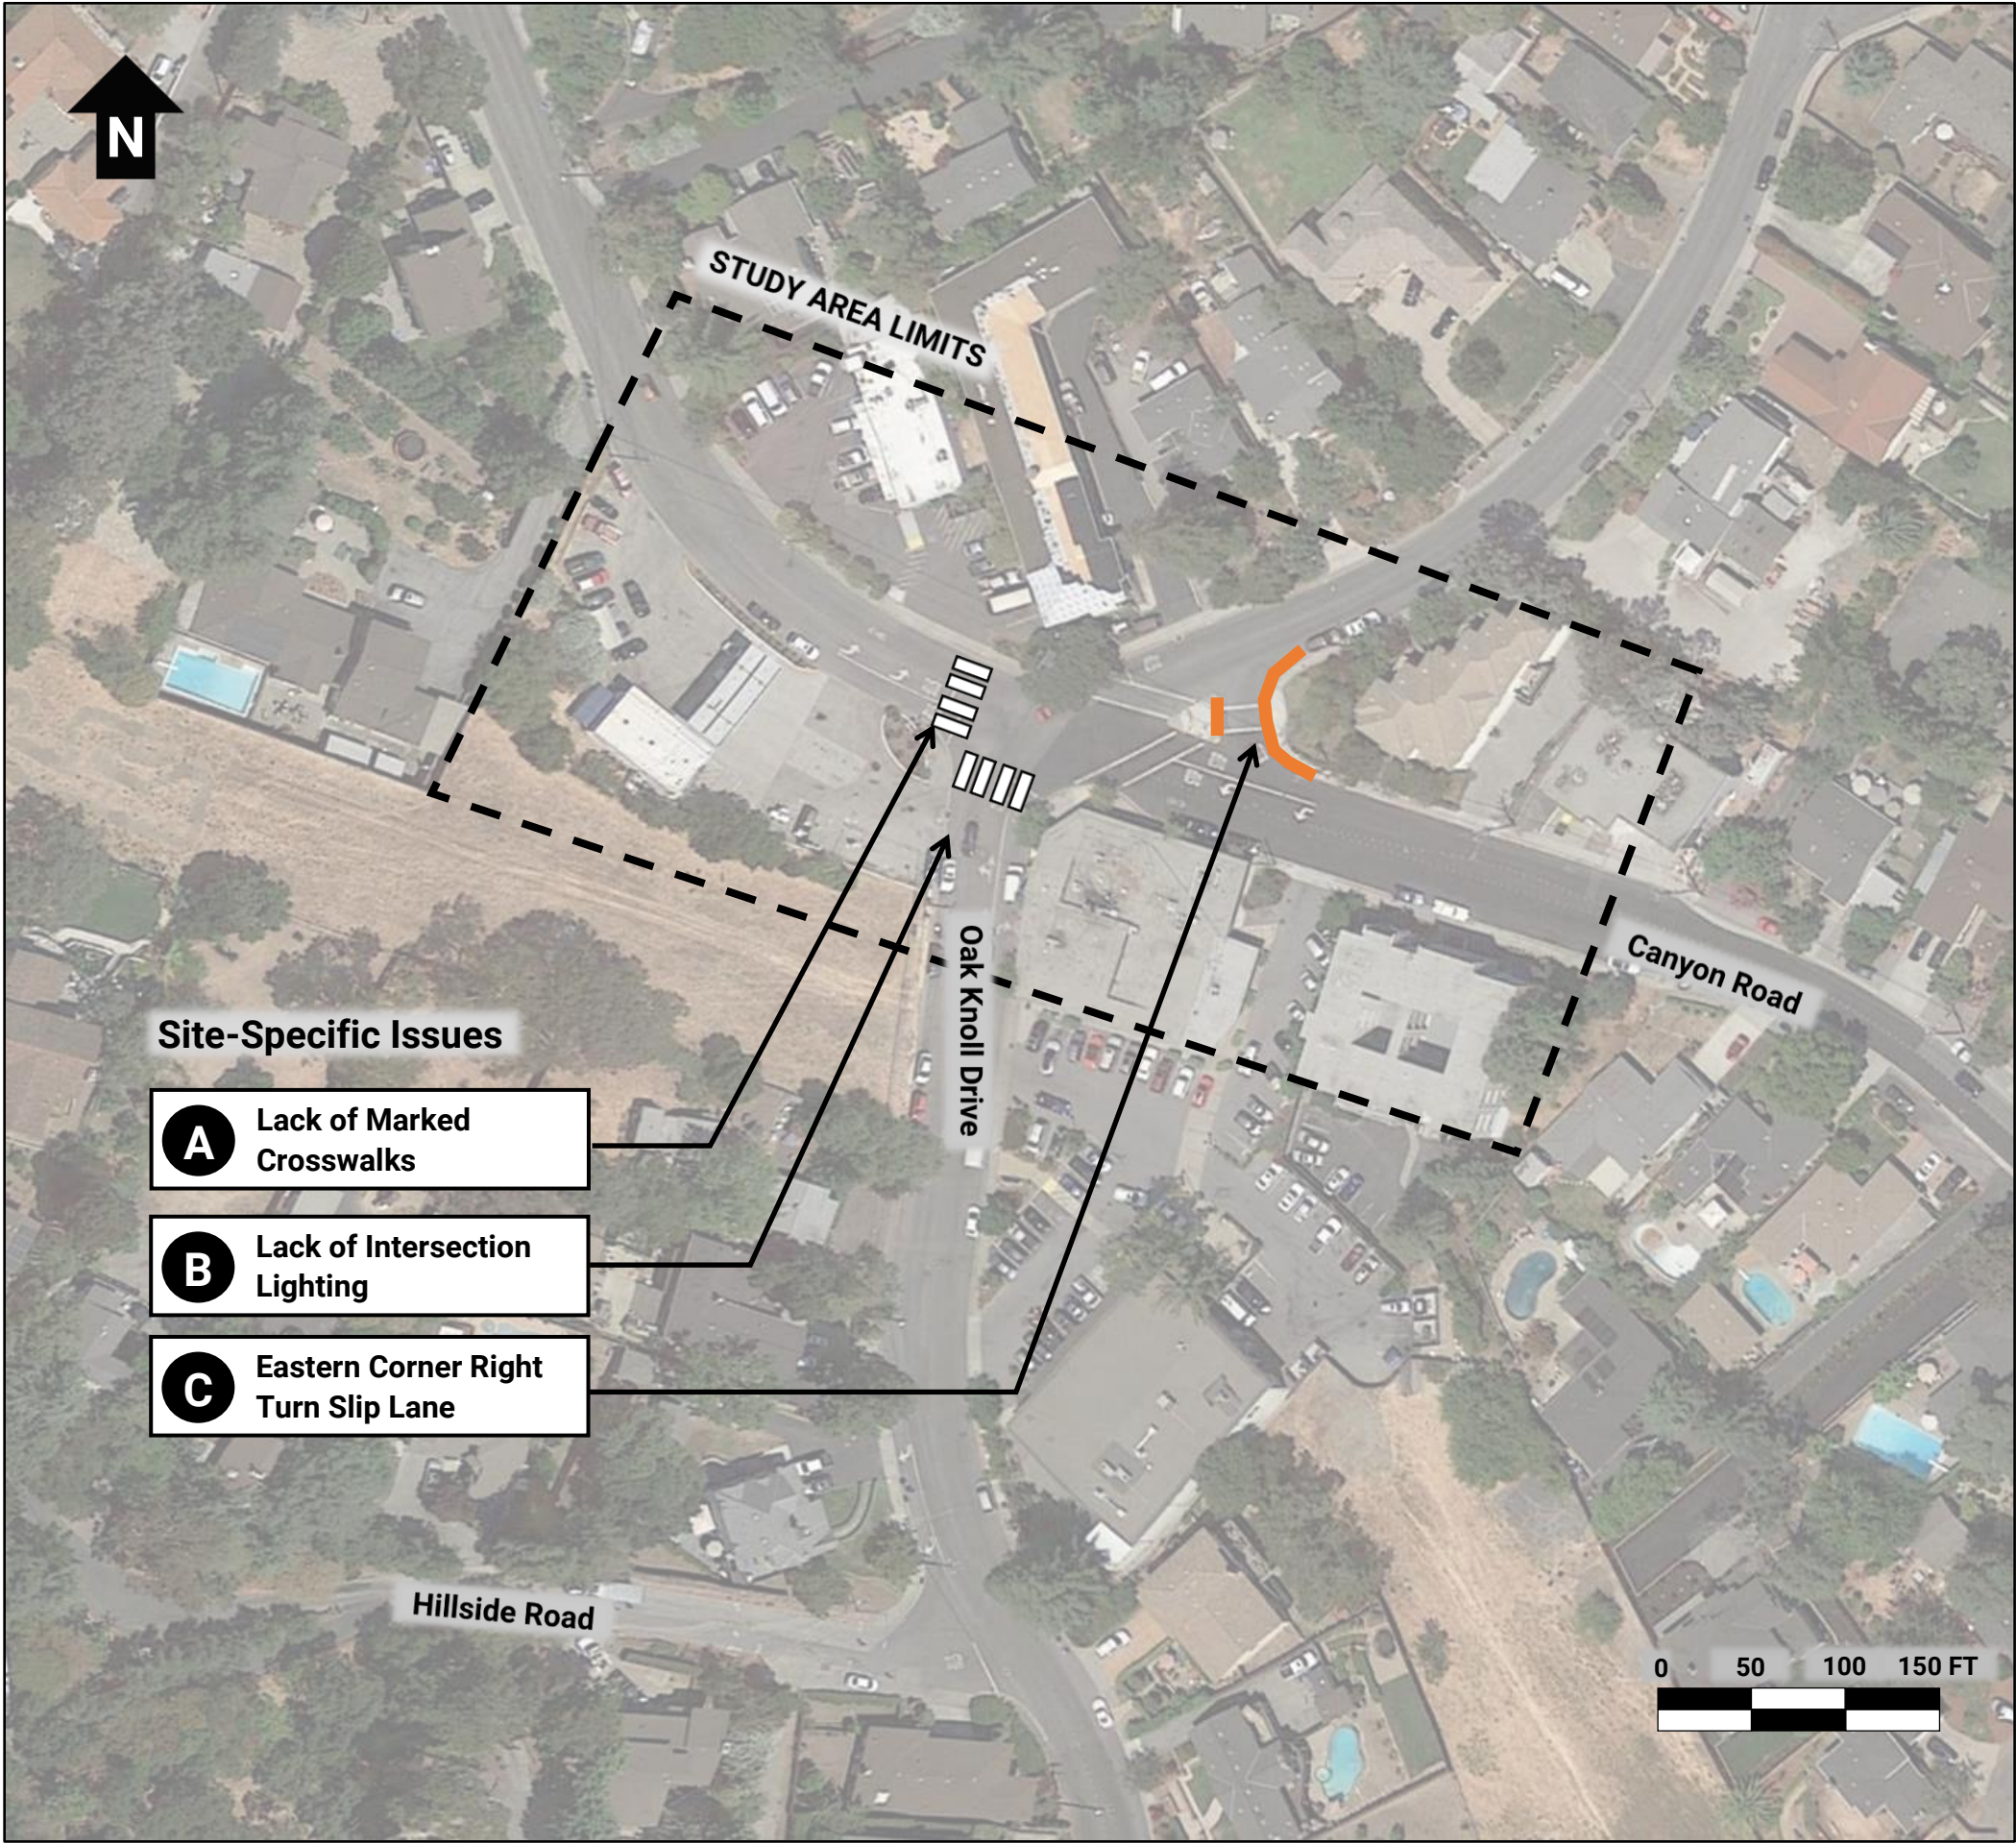
**Figure 11**  
**Study Area 10: Oak Knoll Drive/Canyon Road Intersection**  
Emerald Hills, CA

| | Issue | Recommendation |
|---|---|---|
| A | <b>Lack of marked crosswalks</b> at intersection, resulting in reduced pedestrian conspicuity and safety. | <b>Long-Term</b> <ul style="list-style-type: none"><li>Stripe high-visibility crosswalks along western and southern legs of intersection and upgrade existing crosswalks on eastern and northern legs to high-visibility crosswalks</li><li>When striping crosswalks, construct accessible landings</li></ul> |
| B | <b>Lack of lighting</b> at intersection, resulting in reduced pedestrian conspicuity and safety. | <b>Long-Term</b> <ul style="list-style-type: none"><li>Install intersection lighting to illuminate crosswalks</li></ul> |
| C | <b>Eastern corner right turn slip lane</b> with large radius results in high vehicle turning speeds and unsafe pedestrian crossing conditions. | <b>Short-Term</b> <ul style="list-style-type: none"><li>Narrow slip lane to reduce turning traffic speeds by using quick-build temporary materials like paint and flexible delineators</li></ul> <b>Long-Term</b> <ul style="list-style-type: none"><li>Eliminate slip lane and reconstruct curbline of eastern corner with truck apron to accommodate heavy vehicles making right turn</li></ul> |
