ASSET VULNERABILITY PROFILE | SAN MATEO COUNTY SEA LEVEL RISE VULNERABILITY ASSESSMENT

ASSET VULNERABILITY PROFILE

ASSET VULNERABILITY PROFILE PROJECT BACKGROUND

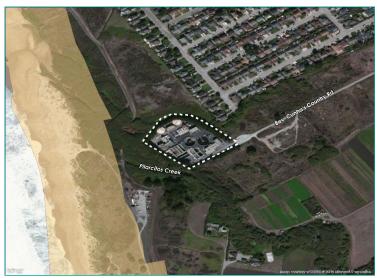
Erosion Extent: Future coastal erosion does not reach asset.

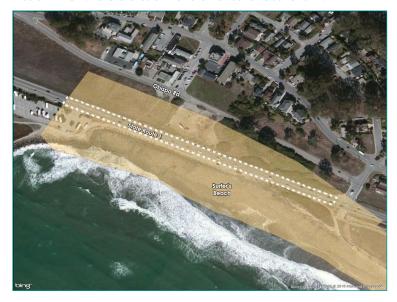
Erosion Extent: Future erosion zone extends far east of SR1.

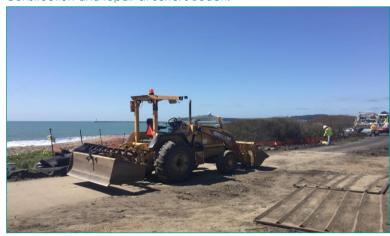
Construction and repair at Surfer's Beach.

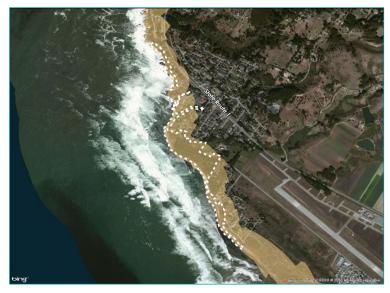
Erosion Extent: Reserve is and will be exposed to coastal erosion.

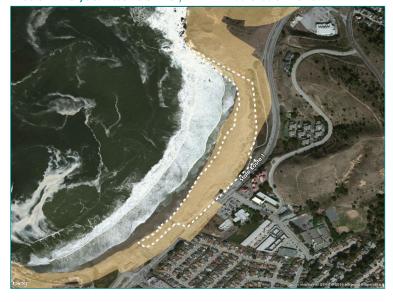
Erosion Analysis: Asset is entirely within 2100 erosion zone.

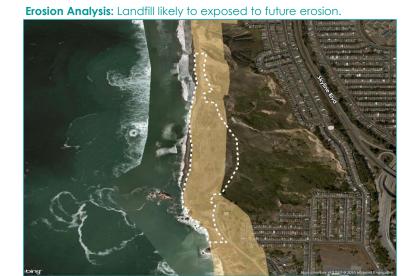
Exposure to erosion at the Landfill is moderate. The 30- to 35-foot-high revetment at the base of the cliff is exposed to daily wave action and high tides requiring spot repairs every few years. The 2016 storms caused erosion in a few areas on the north side that necessitated emergency repair. However, because the landfill is set back slightly from the cliff, and due to the revetment at the base of the cliff, the Landfill and its materials themselves have never been exposed. As sea level rises, however, more frequent severe storms and wave impacts will increase erosion of the revetment and armoring, potentially leading to landslides. Historical erosion data and future erosion projections indicate that this asset and the surrounding area are particularly at risk from erosion (yellow band on the right). The asset will not be exposed to coastal inundation because it is elevated and slopes upward away from the ocean. A groundwater table increase due to sea level rise may expose the Landfill's contents to water from below ground, but this is being monitored.

Erosion at Mussel Rock; though landfill protected by revetment.

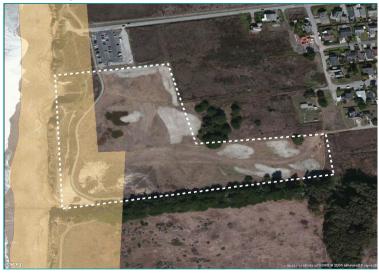
Western edge of landfill within future erosion extent.

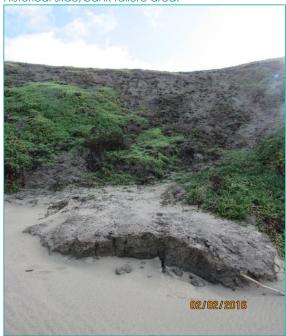
Historical slide/bank failure area.

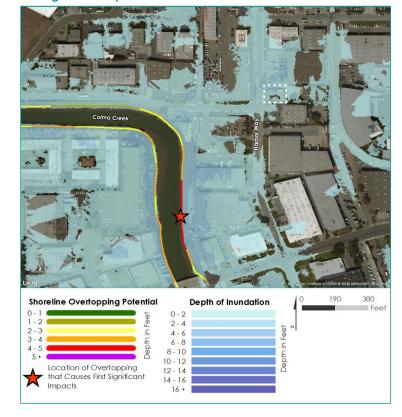
First Significant Impacts: 48 inches above MHHW.

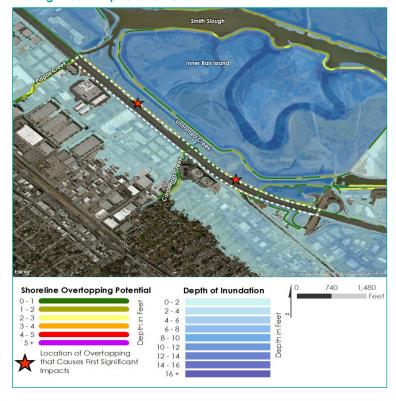
First Significant Impacts: 48 inches above MHHW.

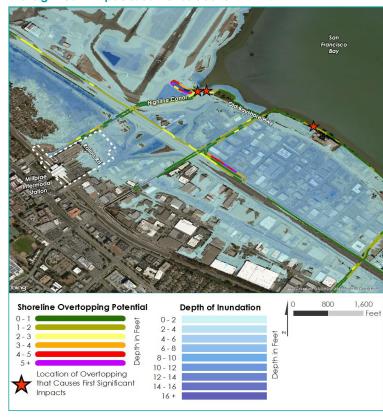
First Significant Impacts: 36 inches above MHHW.

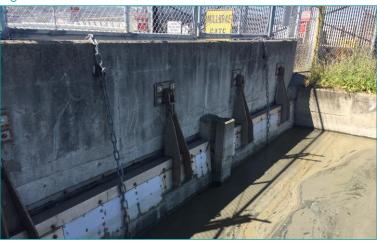
Highline Canal Tide Gates.

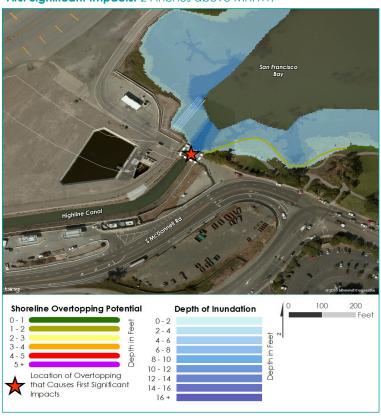
First Significant Impacts: 24 inches above MHHW.

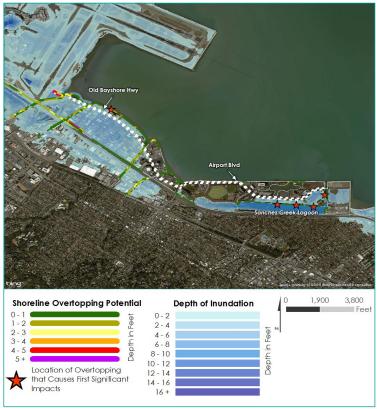
First Significant Impacts: 36 inches above MHHW.

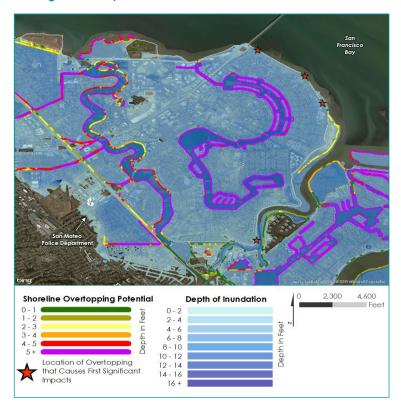
First Significant Impacts: 52 inches of sea level rise.

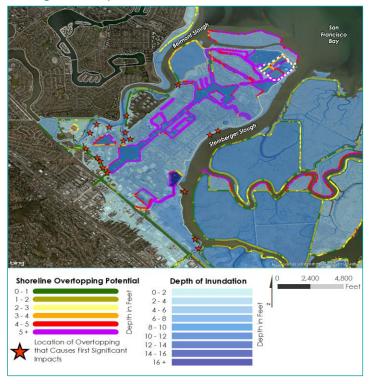
First Significant Impacts: 48 inches of SLR above MHHW.

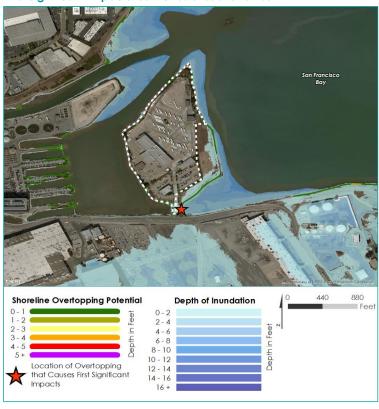
First Significant Impacts: 36 inches of sea level rise.

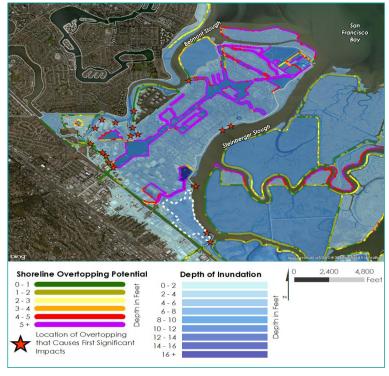
First Significant Impacts: 48 inches above MHHW.

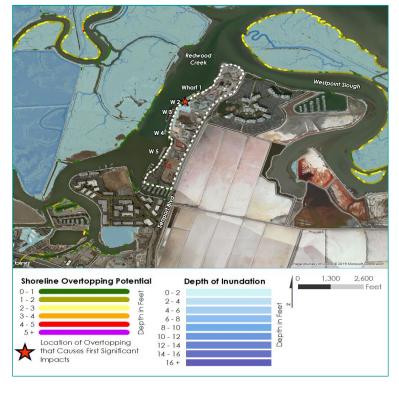
First Significant Impacts: 12 inches above MHHW.

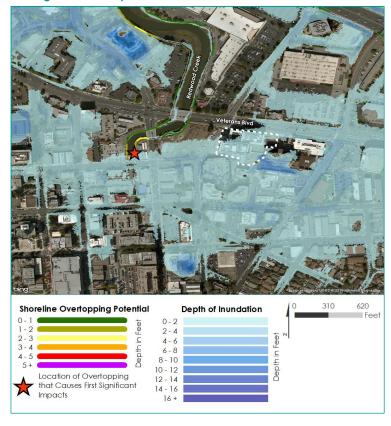
First Significant Disruption: 36 inches above MHHW.

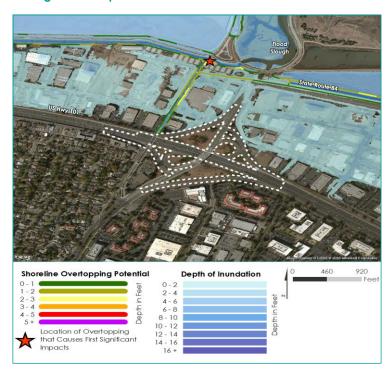
First Significant Impacts: 36 inches above MHHW.

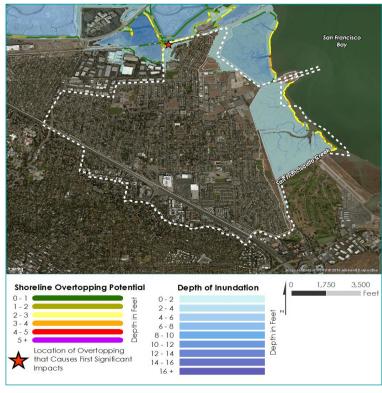
First Significant Impacts: 24 inches of sea level rise.

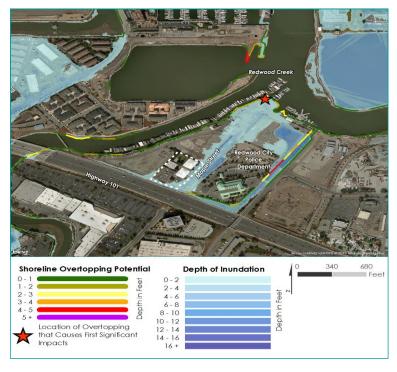
First Significant Impacts: 24 inches above MHHW.

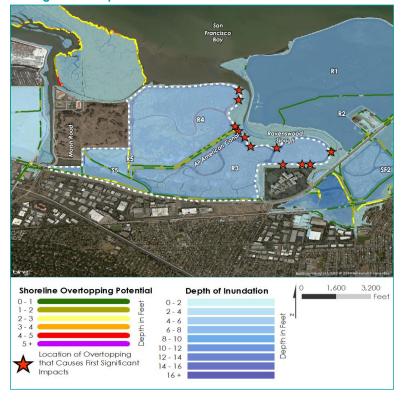
First Significant Impacts: 24 inches above MHHW.

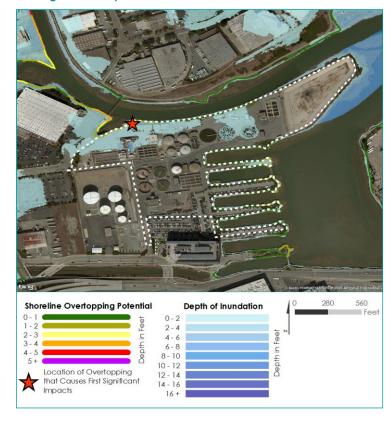
First Significant Impacts: 48 inches above MHHW.

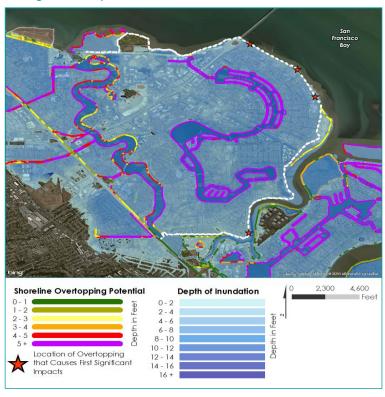
First Significant Impacts: 52 inches above MHHW.

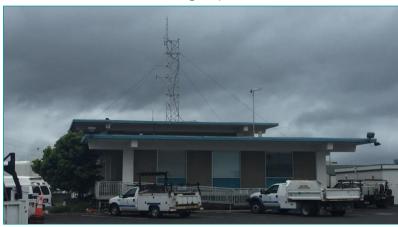
Communication tower with emergency broadcast function.

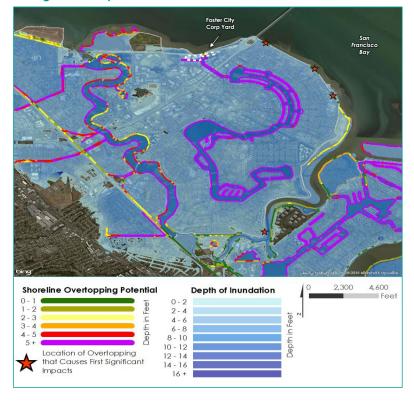
First Significant Impacts: 52 inches above MHHW.

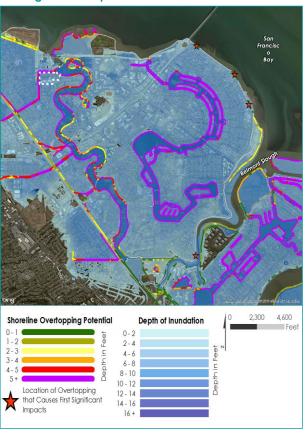
First Significant Impacts: 52 inches above MHHW.

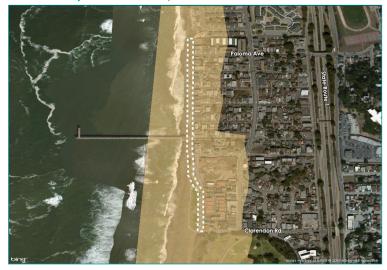
Erosion Analysis: Site is entirely in future erosion area.

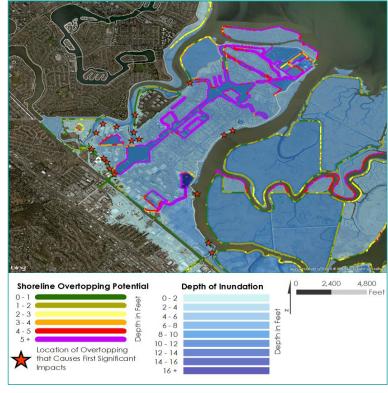
First Significant Impacts: 48 inches above MHHW.
